Assessment of coastal defence structures at Old Ranges, Shoeburyness

November 2015

Southend-on-Sea Borough Council

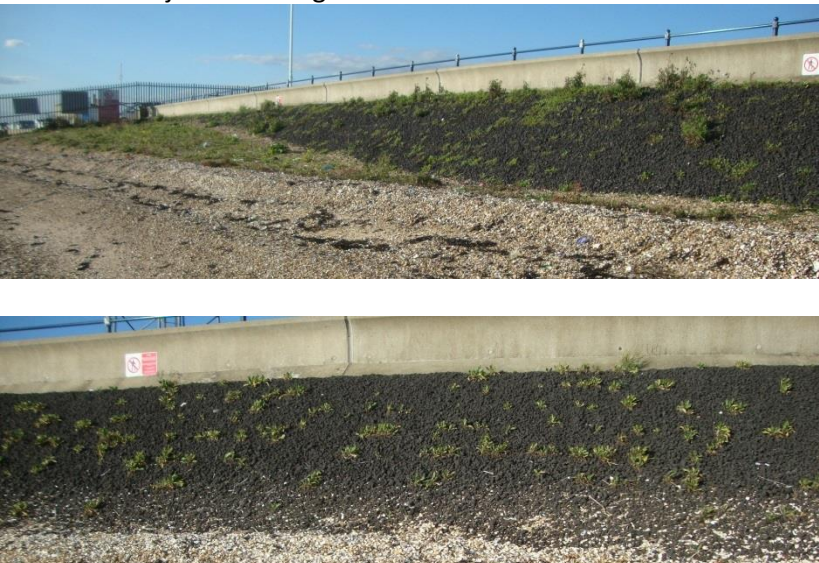
Chainage	Groyne No.	Sea Wall Repair Works listed in Plan 11012606-01 C4	Comments
0-50			<p>DESIRABLE REPAIR: Vegetation on the revetment faces should be removed and joints made good with sealant</p>

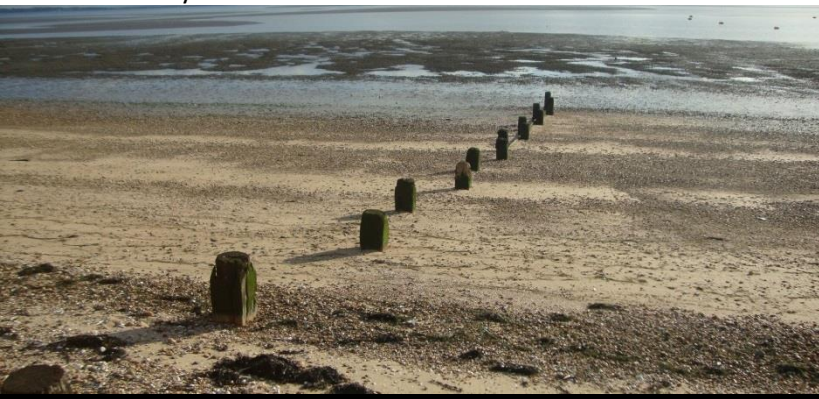
50-100	1		<p>Groyne 1 is currently completely below beach level so could not be checked visually.</p>

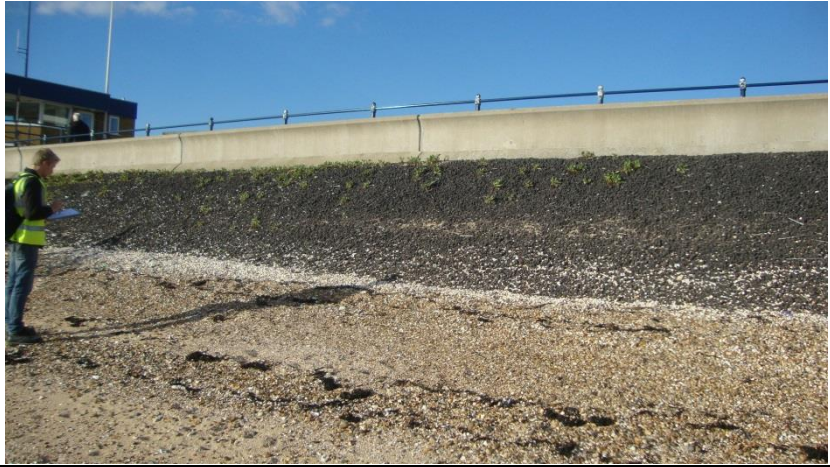
100-150			<p>DESIRABLE REPAIR: Vegetation on the revetment faces should be removed and joints made good with sealant</p>

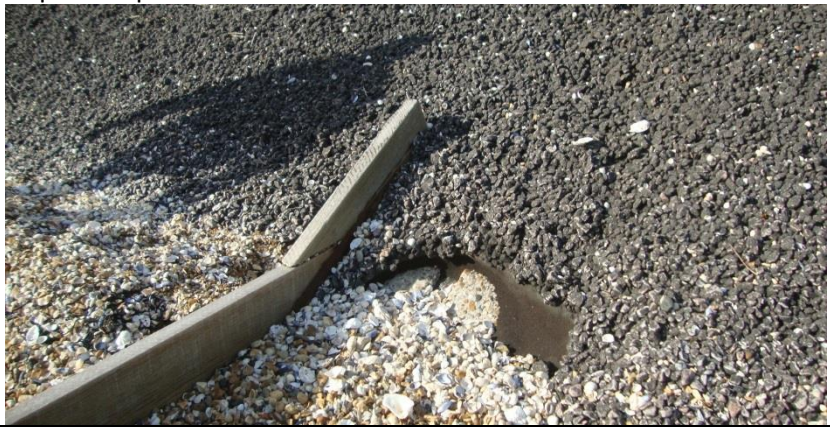
2		
150-200	3		
		Repair required to damaged OSA	<p>Not Complete. ESSENTIAL REPAIR: Damaged OSA (10's of cm's) requires repair</p>

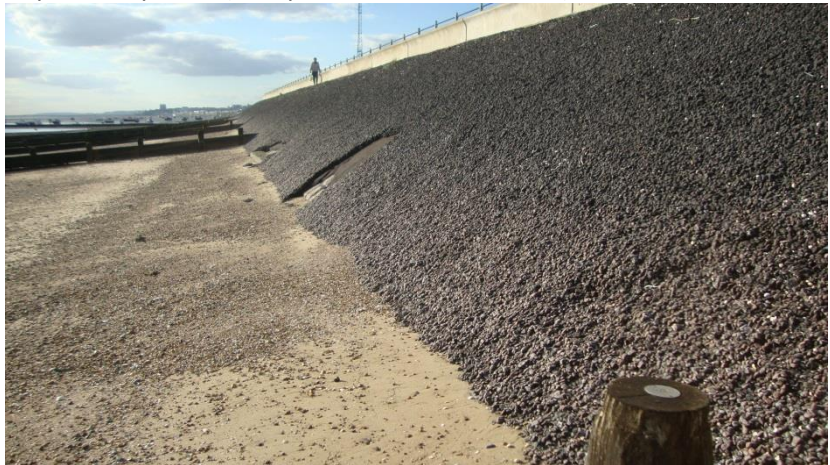
<p>Repair fractured concrete face with Open Stone Asphalt</p>	<p>Repair completed (except 2 areas noted below)</p>

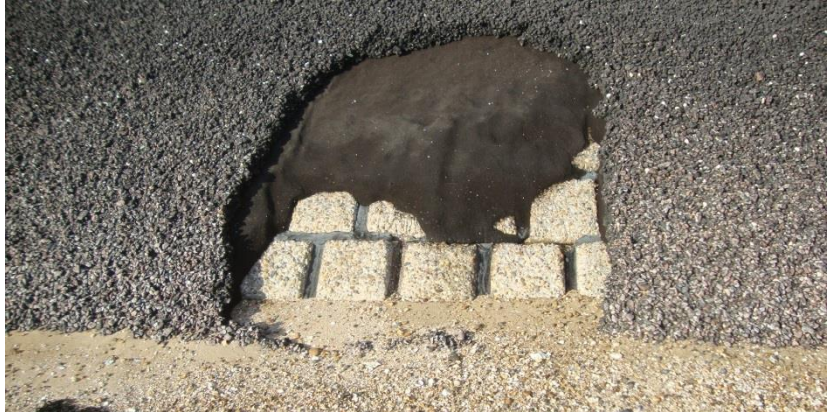
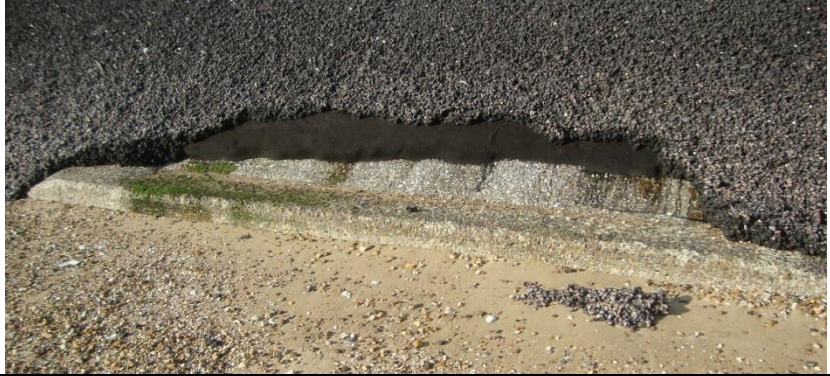
<p>ESSENTIAL REPAIR: Two further (m) repairs required to OSA</p>

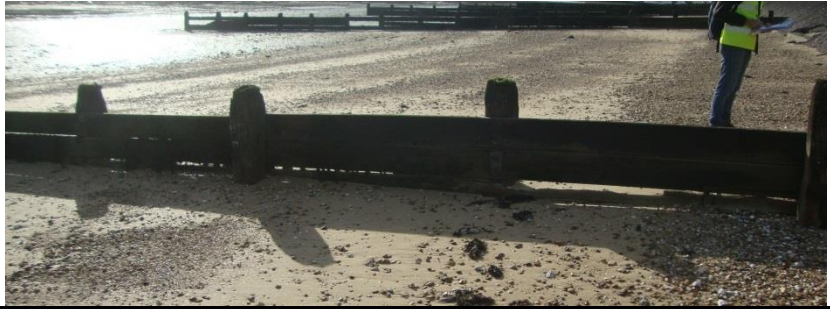
250-300	6		<p>ESSENTIAL REPAIR: A plank missing from the base of the groyne requires replacing</p>

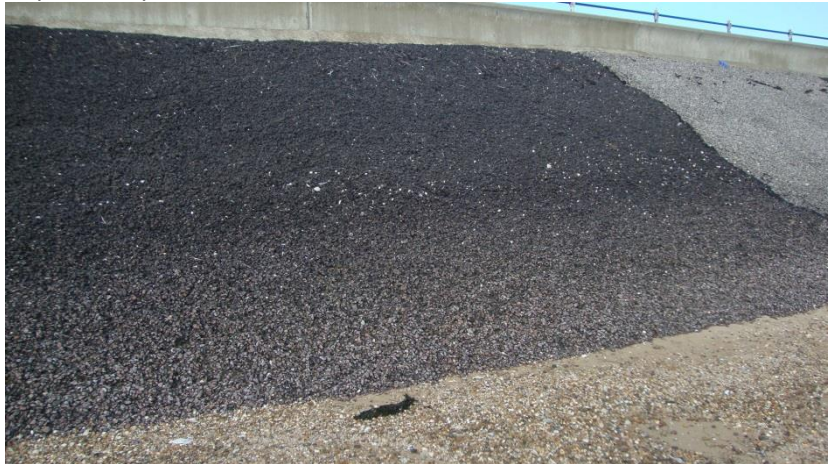
<p>Repair fractured concrete face with Open Stone Asphalt</p>	<p>Repair completed</p>

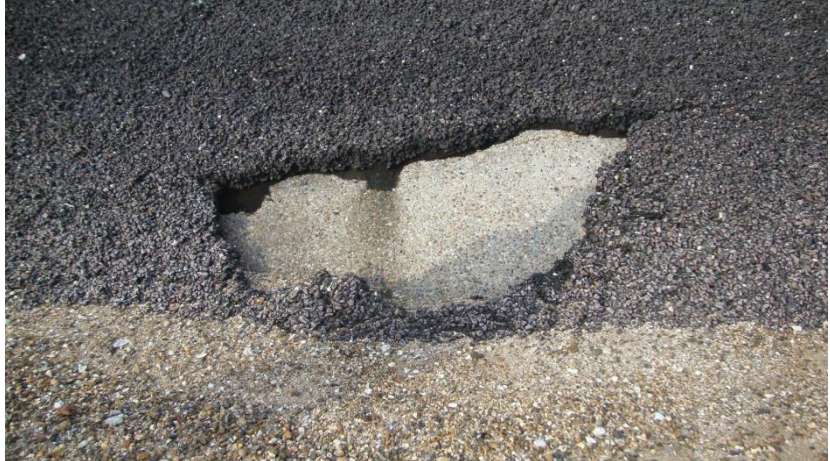
<p>ESSENTIAL REPAIR: Further repair required to OSA</p>

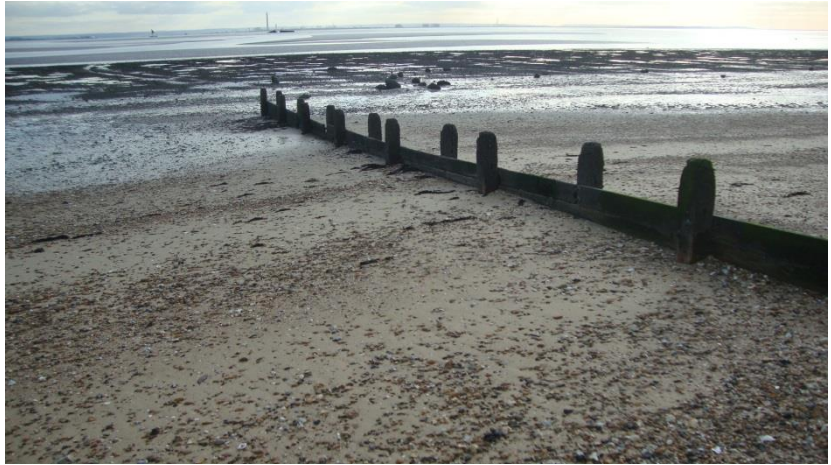
7		<p>Planks are missing from the top layer of this groyne. These were removed deliberately to encourage some sand movement. Hence these planks are not to be replaced.</p>

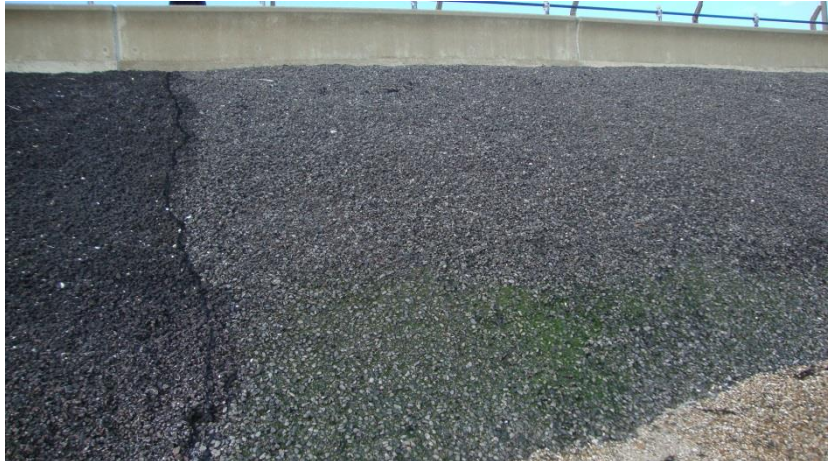
300-350		<p>Repairs to concrete face of wall. New sealant required</p>	<p>Repair completed (concrete face resurfaced with OSA). ESSENTIAL REPAIR: Join between OSA has been sealed however minor (cm) damage at bottom of join should be repaired.</p>

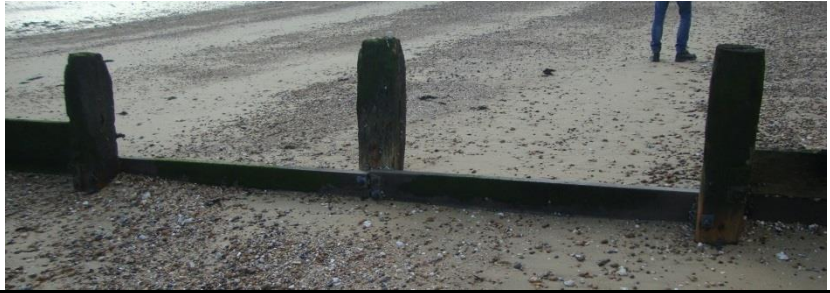
8		<p>ESSENTIAL REPAIR: Two planks missing from the top layer of the groyne</p>

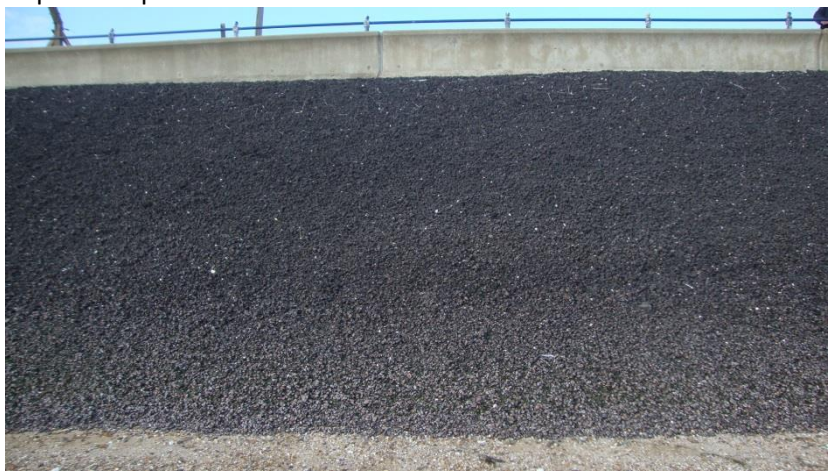
<p>Repair fractured concrete face with Open Stone Asphalt</p>	<p>Repair completed</p>

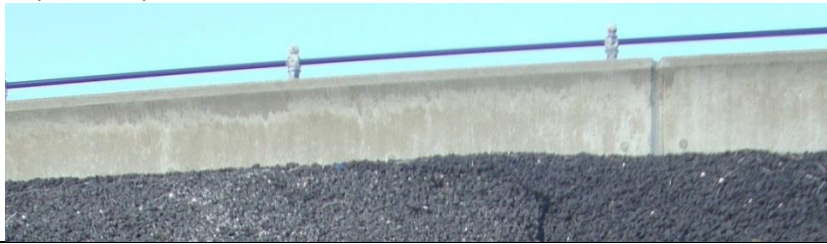
Repair rust staining to top of wavewall	Repair completed

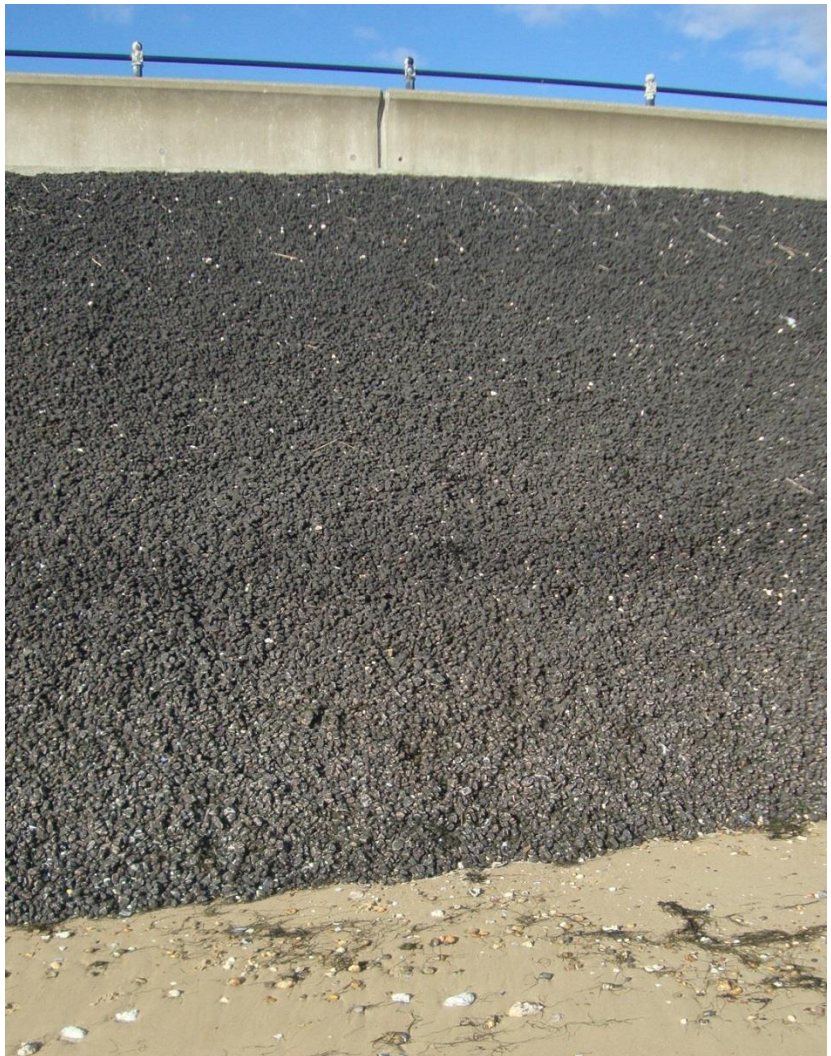
<p>'Sinking wall' to be investigated by removing Essex blocks. Repair if necessary.</p>	<p>From visual assessment repair appears to have been completed. Due to high beach levels it was not possible to assess the condition of the toe of the sea wall.</p>

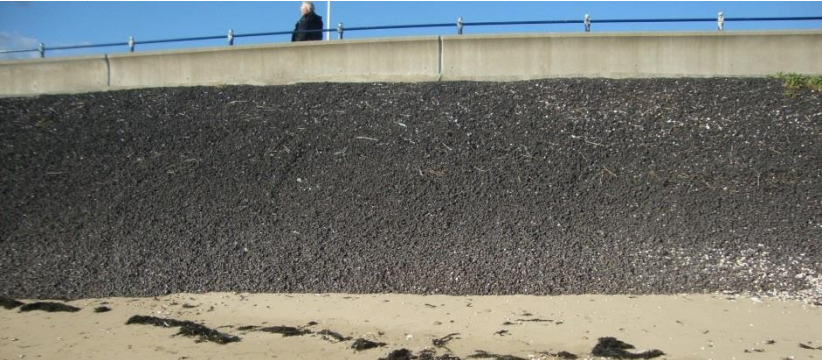
<p>'Sinking wall' to be investigated by removing Essex blocks. Repair if necessary.</p>	<p>From visual assessment repair appears to have been completed. Due to high beach levels it was not possible to assess the condition of the toe of the sea wall.</p>

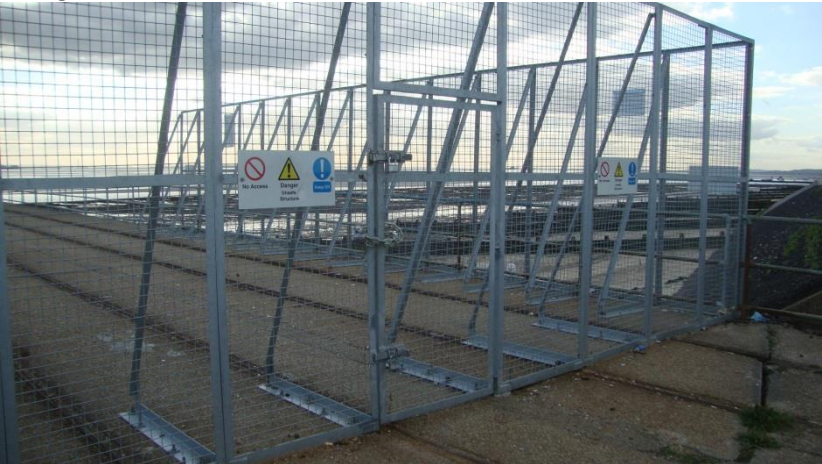
<p>500-550</p>		<p>Barge Pier New security fencing</p>	<p>Fencing completed. The only deviation from design noted was a minor change in the signage. 3 signs read 'No Access', 'Danger Unsafe Structure', and 'Keep Off' as opposed to the one sign stating 'Dangerous Structure Unauthorised Access Prohibited'</p>

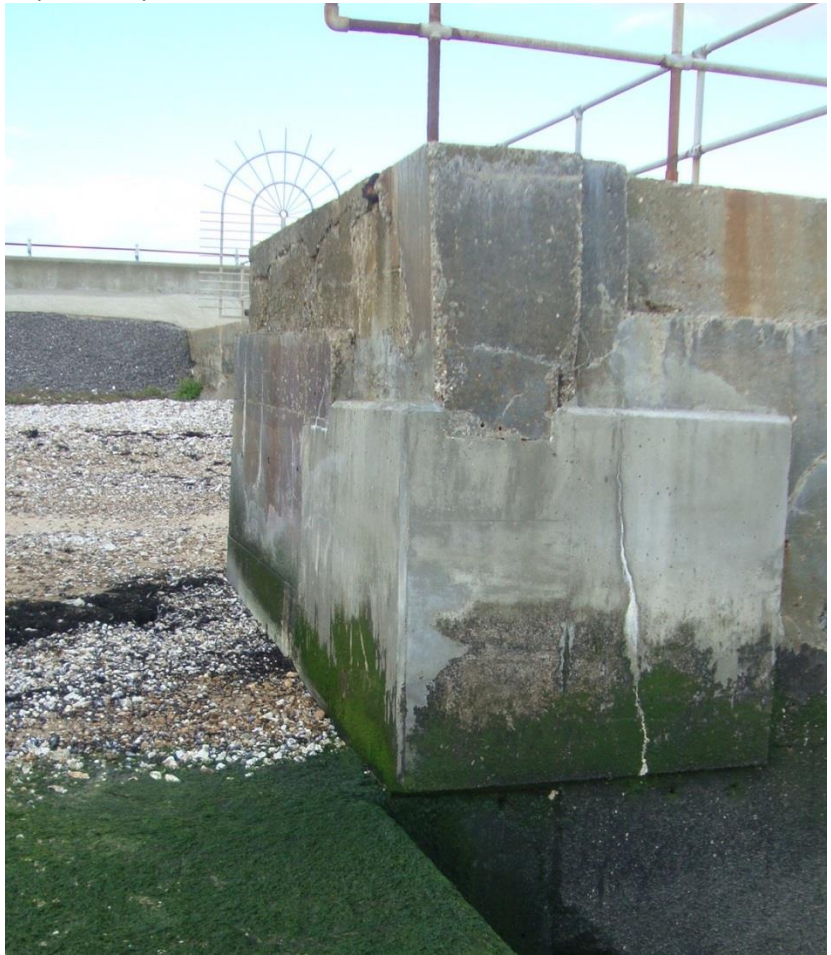
<p>Gog's Berth + Sea Outfall</p> <p>Break out existing damaged concrete corner and repair with reinforced concrete</p>	<p>Repair completed.</p>

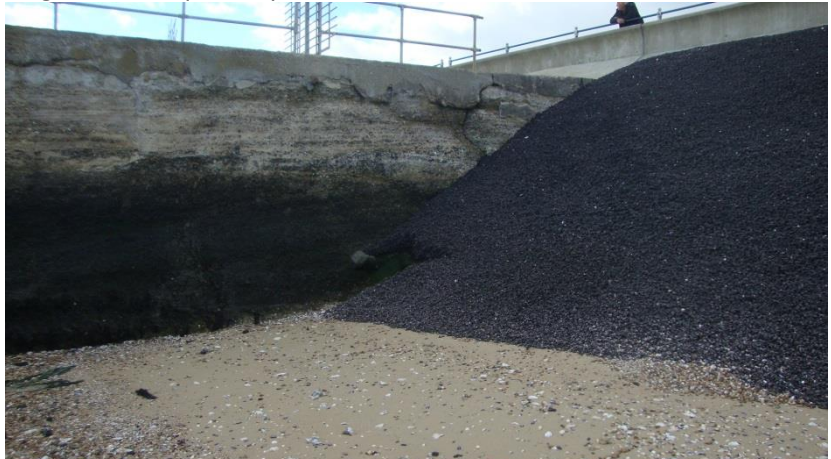
<p>550-600</p>		<p>New sealant required</p>	<p>Sea wall resurfaced with OSA. ESSENTIAL REPAIR: Some cracks in Gog's berth require repair.</p>

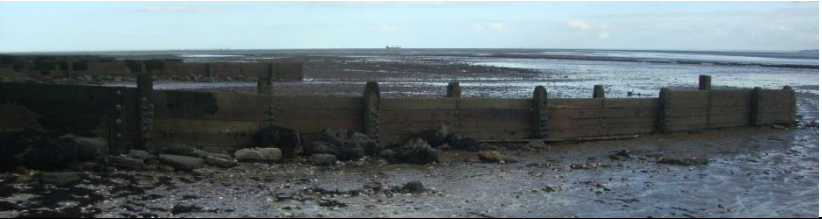
15		<p>Planks are missing from the top layer of this groyne. These were removed deliberately to encourage some sand movement. Hence these planks are not to be replaced.</p>

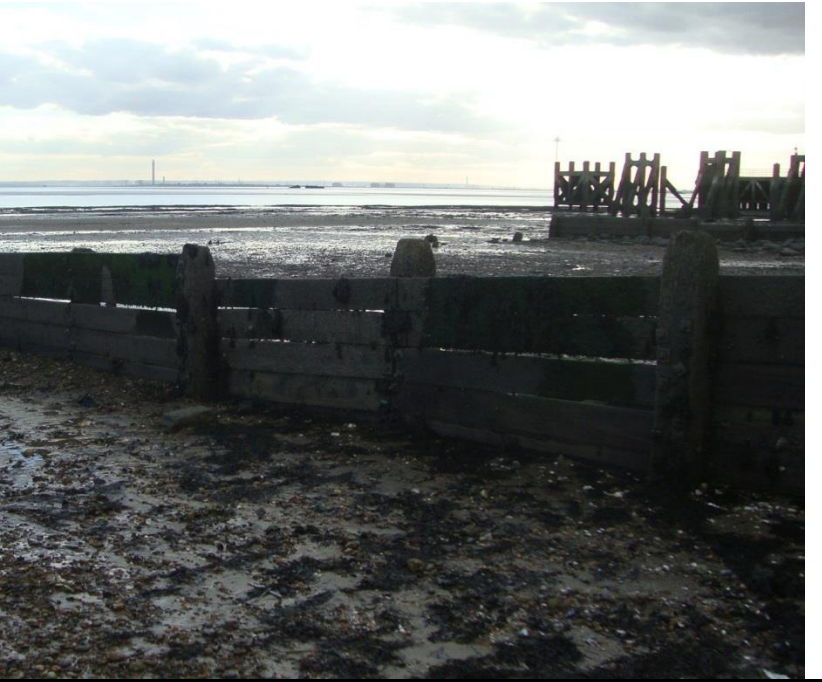
600-650	16		<p>DESIRABLE REPAIR: Planks missing from the top layer of the groyne.</p>

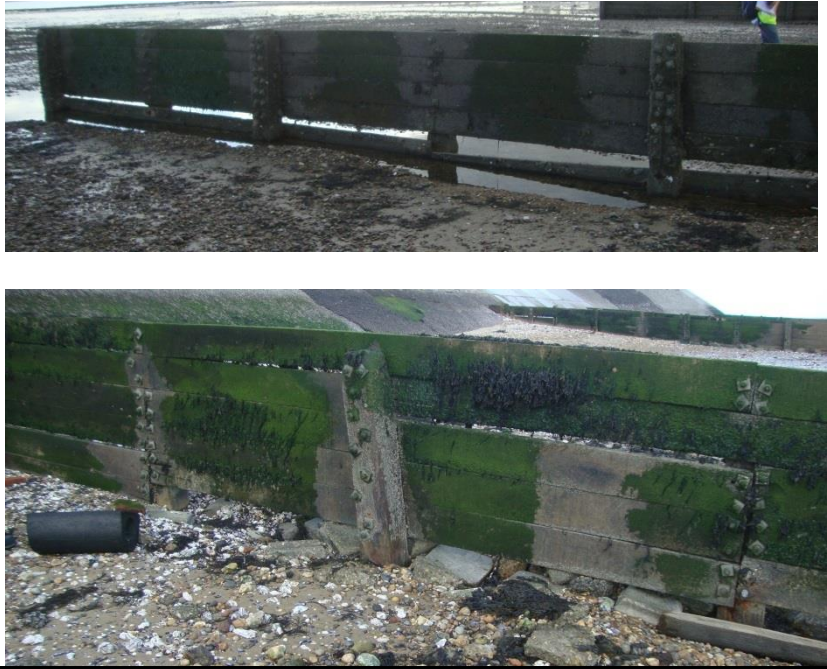
17		<p>ESSENTIAL REPAIR: Planks missing from the base of the groyne require replacing</p>

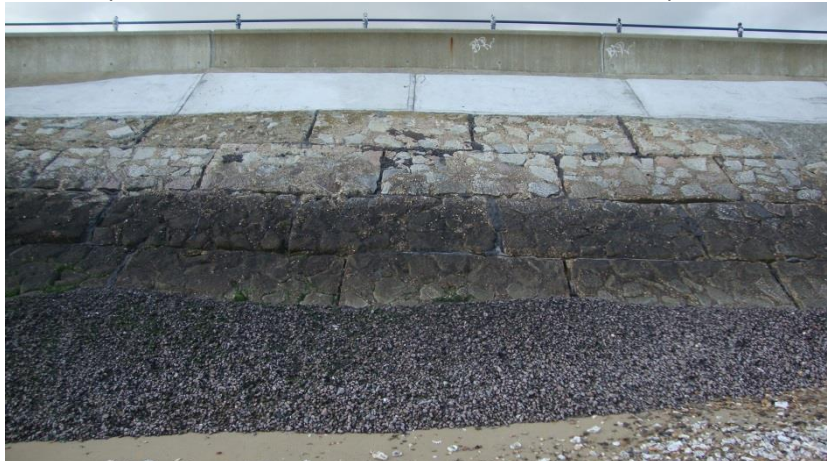
650-700		New sealant required	<p>Not completed. ESSENTIAL REPAIR: New sealant still required</p>

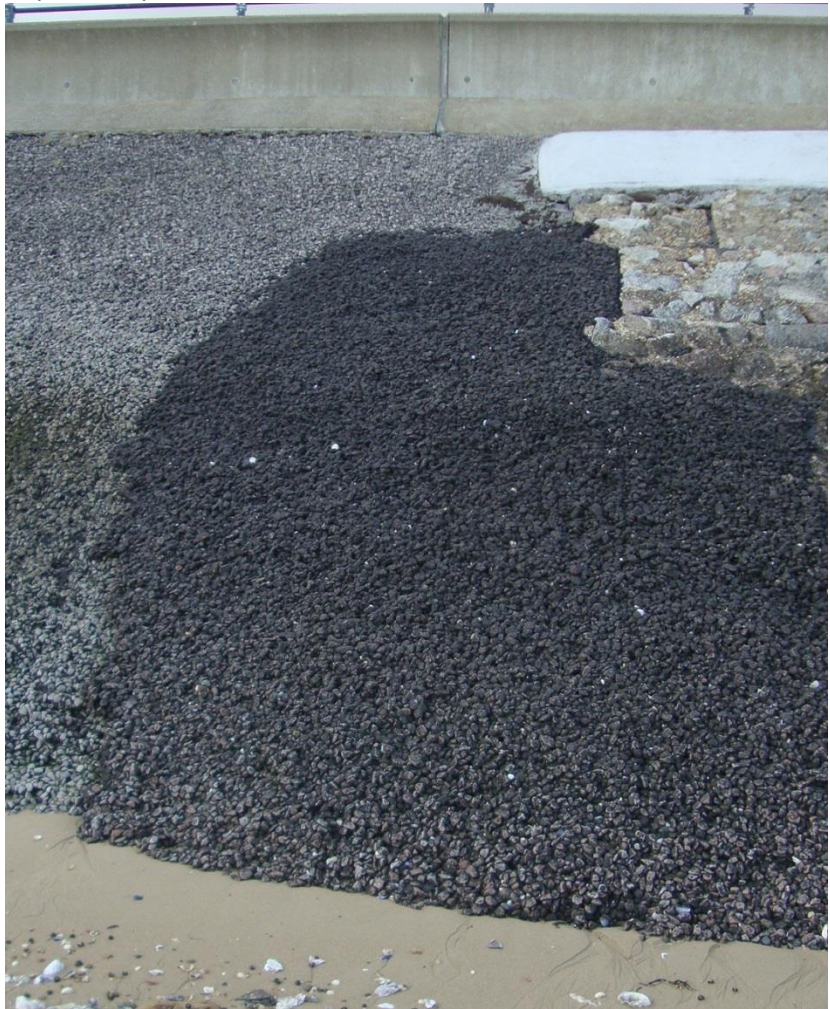
<p>Repair undermined toe of wall</p>	<p>Repair completed</p>

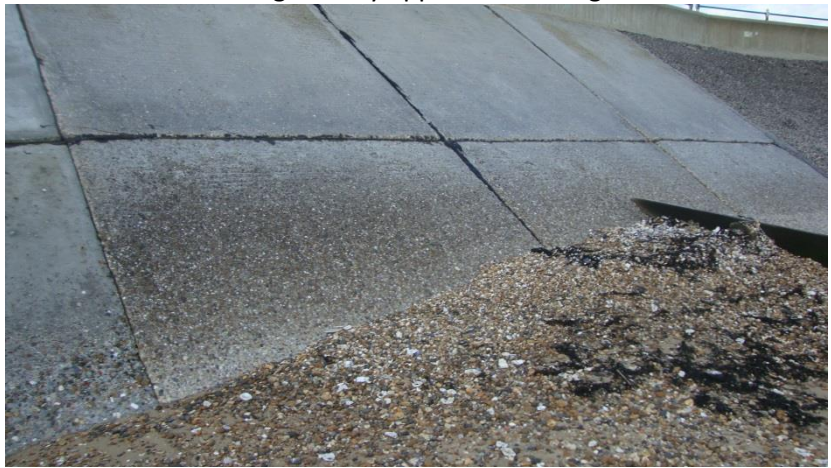
<p>Repair undermined toe of wall</p>	<p>The level of the beach does not allow the visual assessment of the condition of the toe of the wall below beach level but the sea wall above the beach level generally appears to be in good condition.</p>

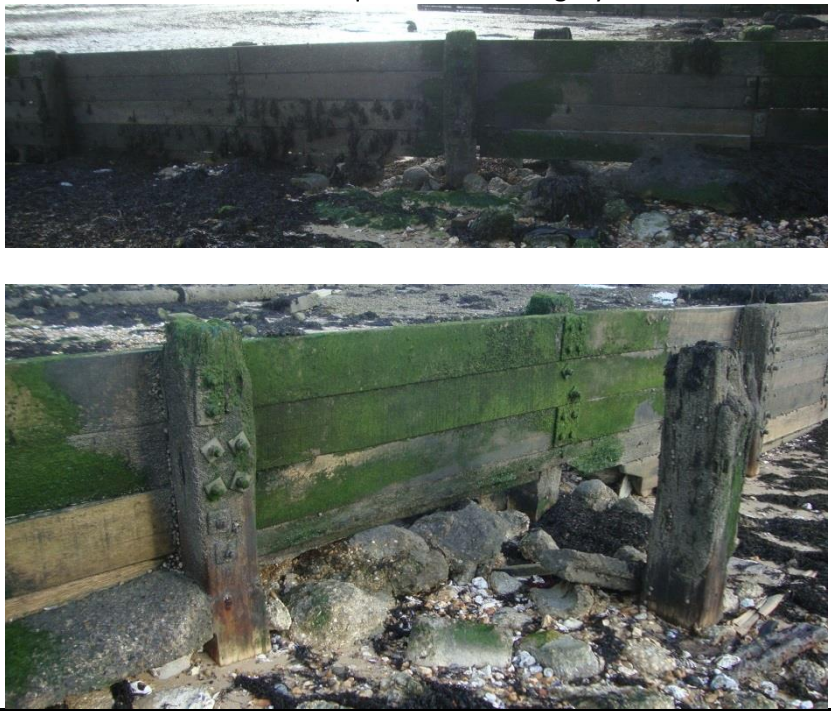
<p>19</p>		
<p>700-750</p>	<p>20</p>		<p>ESSENTIAL REPAIR: Planks required at base of groyne.</p>

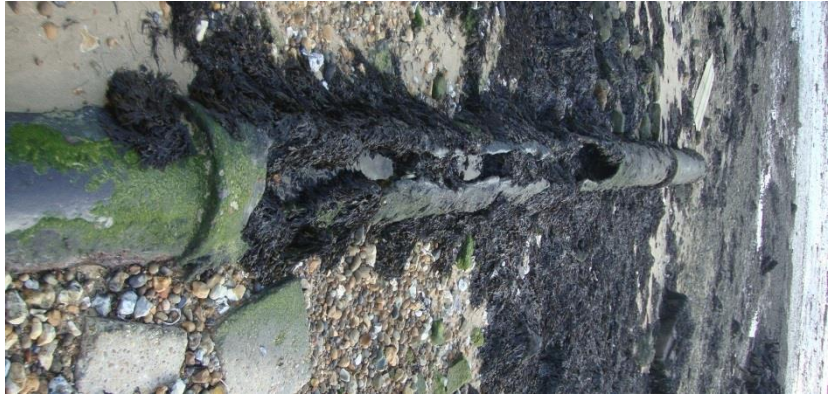
<p>Outfall pipe damaged (outside scope of repairs and assessment but noted for completeness)</p>

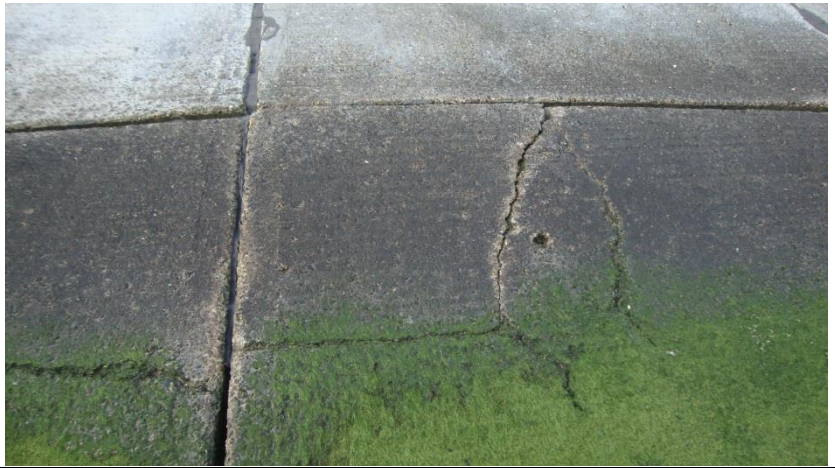
21		
750-800			<p>Not satisfactorily completed. ESSENTIAL REPAIRS: Further repointing is recommended to reduce weathering and erosion. Sealing of cracks is recommended.</p>

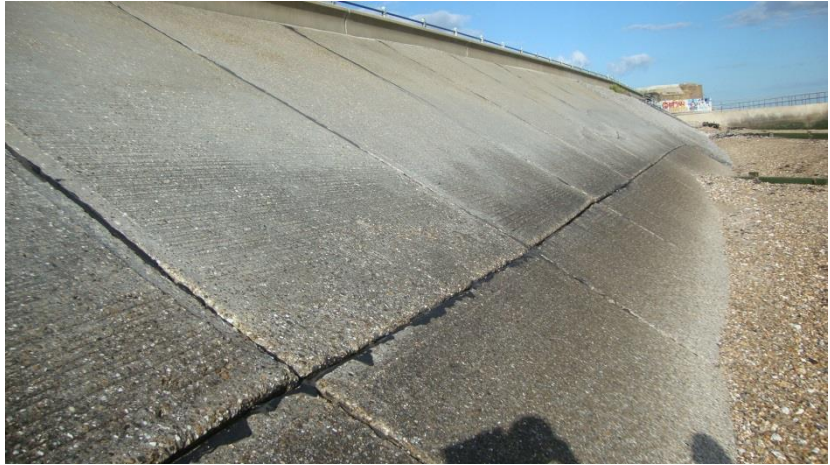
800-850		Repointing and new sealant required	<p>Not satisfactorily completed. ESSENTIAL REPAIRS: Further repointing/sealing is recommended to reduce weathering and erosion.</p>

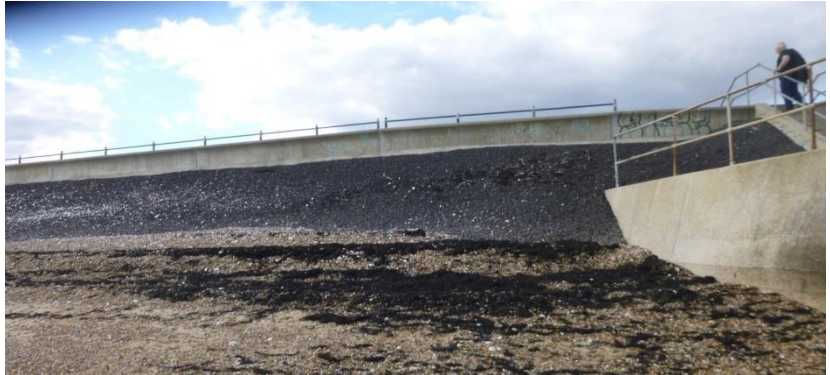
24		
		Repointing and new sealant required	<p>The planned repair is no longer necessary due to satisfactory resurfacing of a new OSA revetment</p>

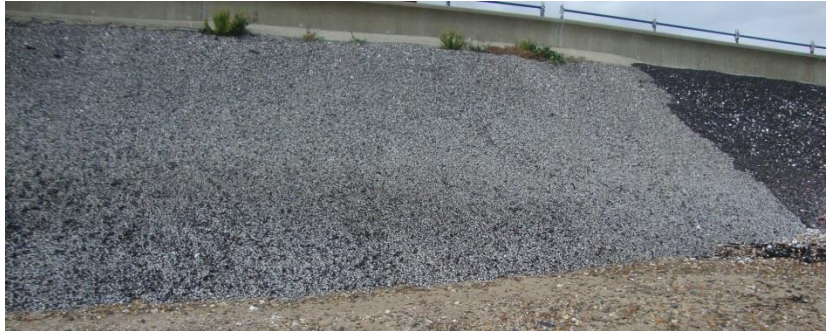
850-900		Repointing and new sealant required	<p>The planned repair is no longer necessary due to satisfactory resurfacing of a new OSA revetment</p>

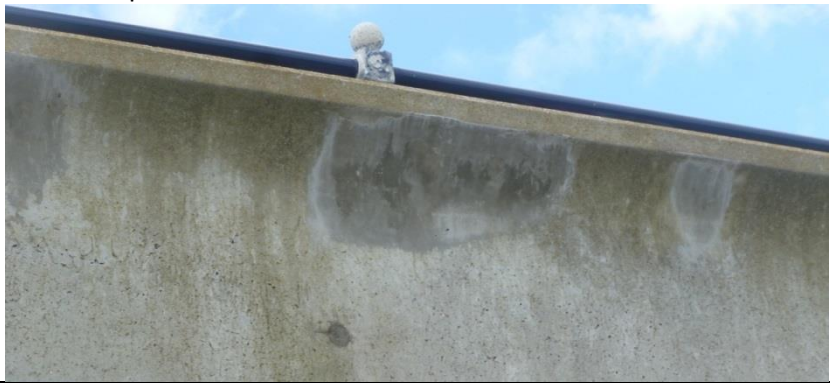
25 A		
	25 B		
900-950		Repair rust staining to face of seawall	<p>Work completed to satisfaction</p>

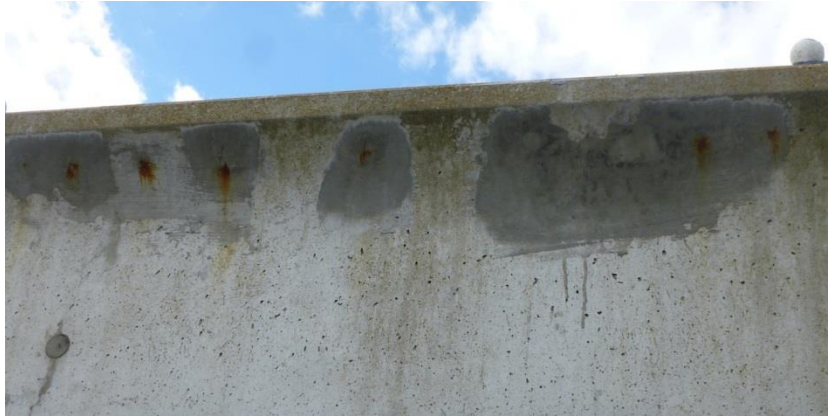
<p>Repair rust staining to face of seawall</p>

<p>Repair seems to have been attempted, however rust stains are still evident.</p>
950-1000	28		
	29	<p>ESSENTIAL REPAIR: Significant (centimetres) cracks between concrete block structures require sealing</p>

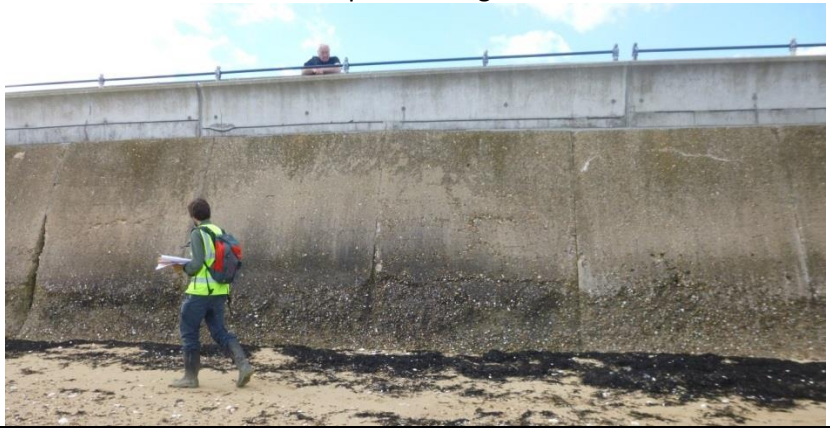
<p>ESSENTIAL REPAIR: Significant (centimetres) cracks between concrete block structures require sealing</p>

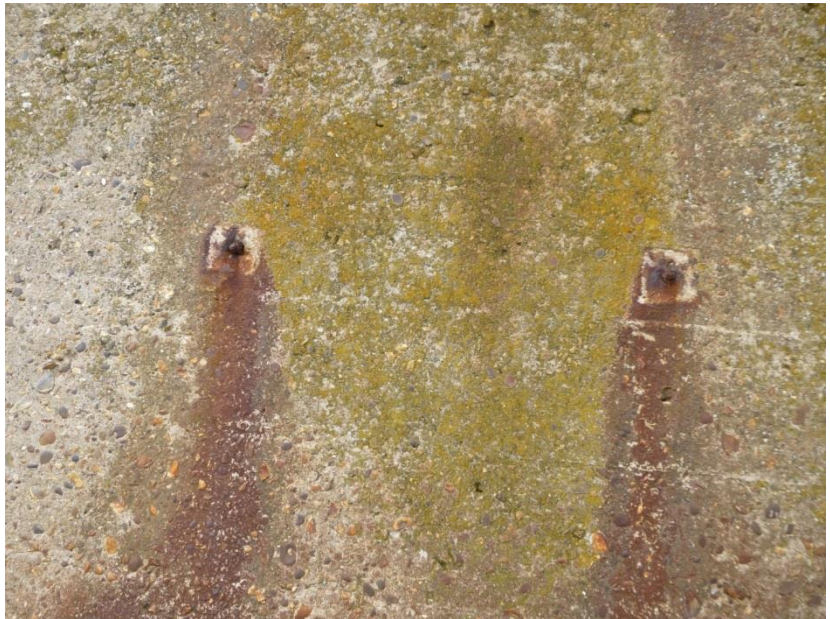
Remove metal ladder and landing plate	<p>Repair has not been satisfactorily completed. The metal ladder and landing plate have been removed. However the metal fixings have not been removed, nor made flush with the face of the concrete using repair mortar. DESIRABLE REPAIR: The metal fixings should be removed or made flush with the face of the concrete using repair mortar</p>

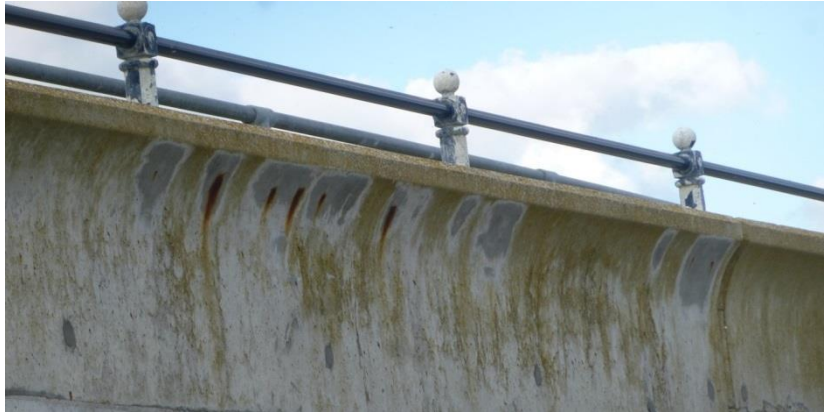
<p>Repair rust staining to face of seawall</p>

<p>Repair has been attempted, however there are still rust staining marks.</p>
	32

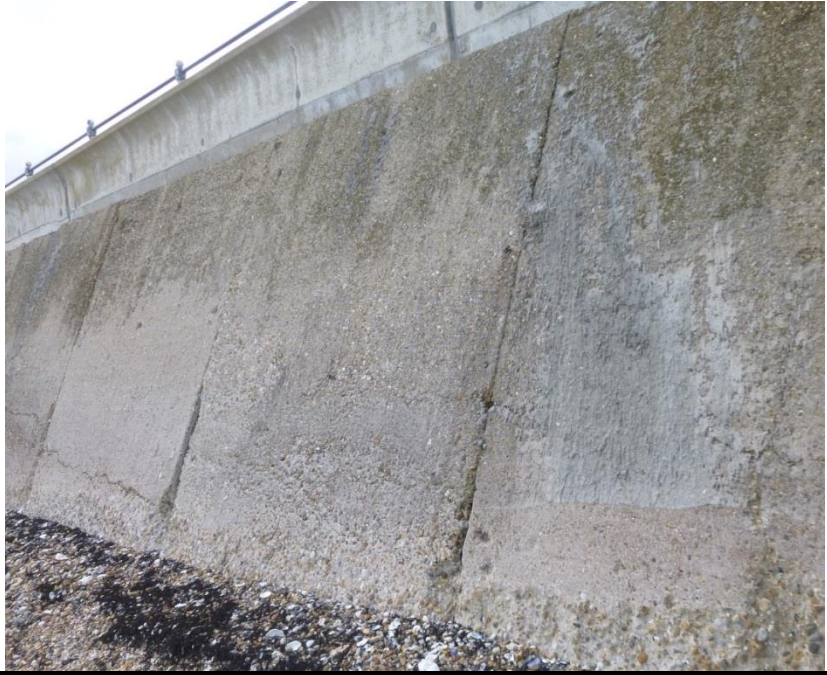
<p>ESSENTIAL REPAIR: Repair of cracks with sealant is recommended.</p>
1050-1100	33		
	34

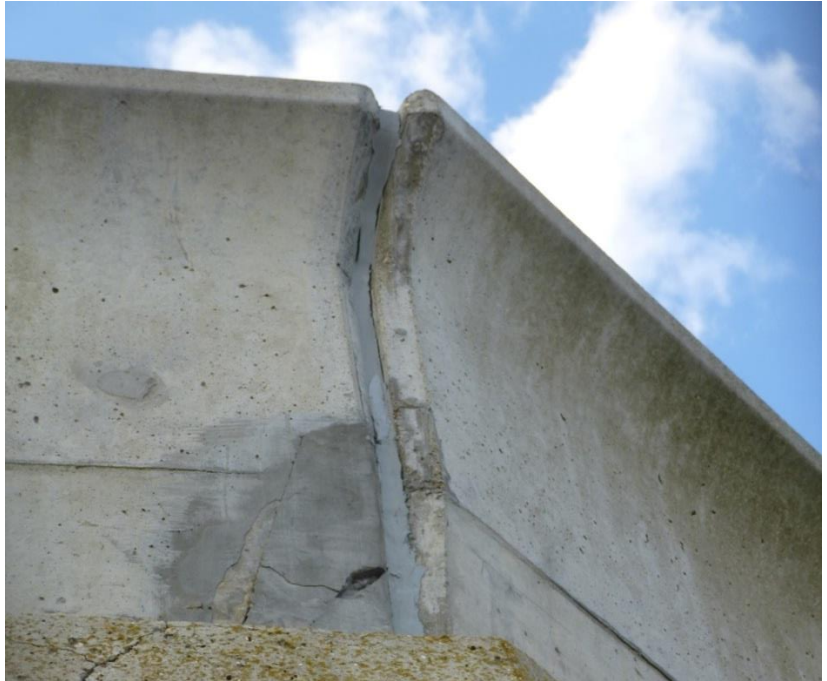
1150-1200		Repair spalled concrete to wavewall corner	ESSENTIAL REPAIR: Completed, but with evidence of minor defects that require repair.

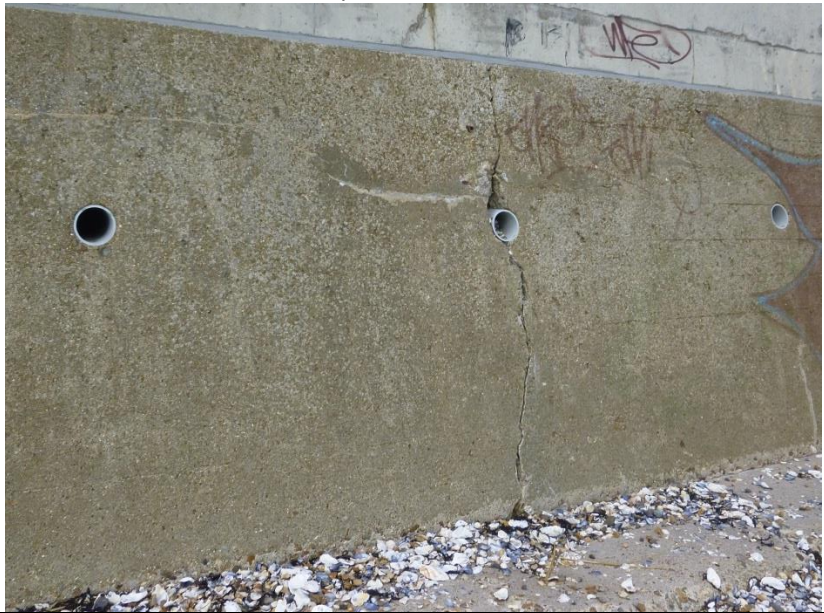
ESSENTIAL REPAIR: Not completed, cracks have not been sealed
		Remortar/seal cracks in face of wall

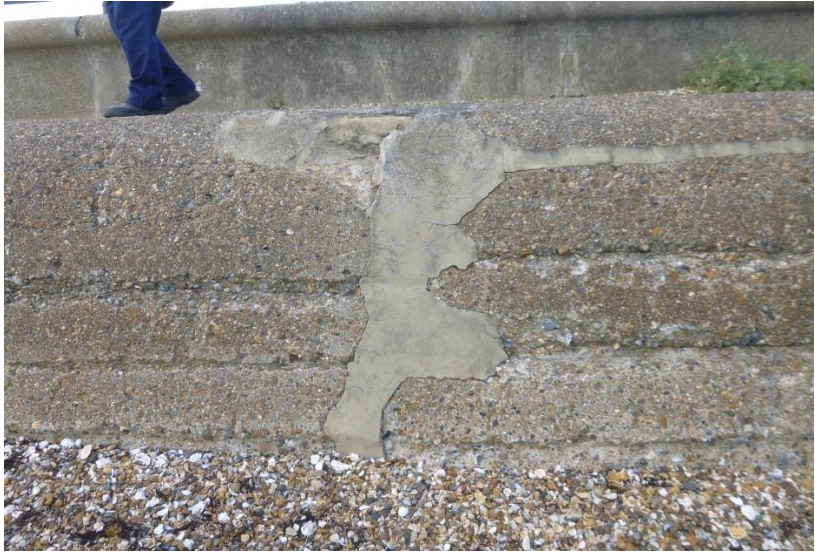
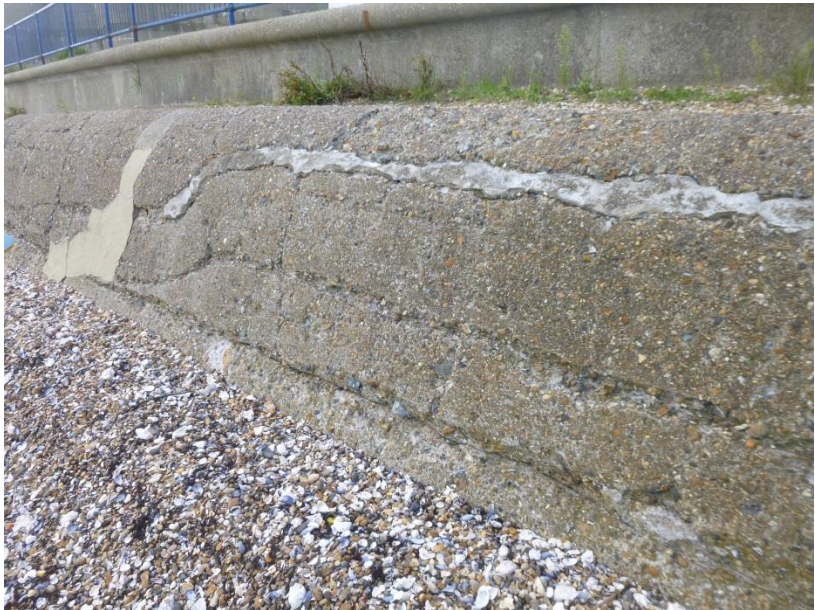
<p>Repair cracks to concrete</p>	<p>Repairs completed with some minor defects. ESSENTIAL REPAIR: Further repairs to the cracks are recommended.</p>

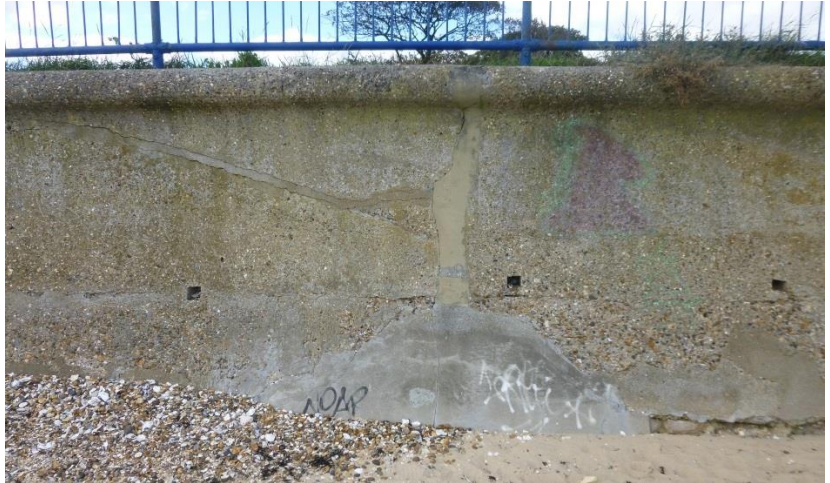
1250-1300		Repair cracks to concrete	<p>ESSENTIAL REPAIRS: Repairs completed, however small defects need repair</p>

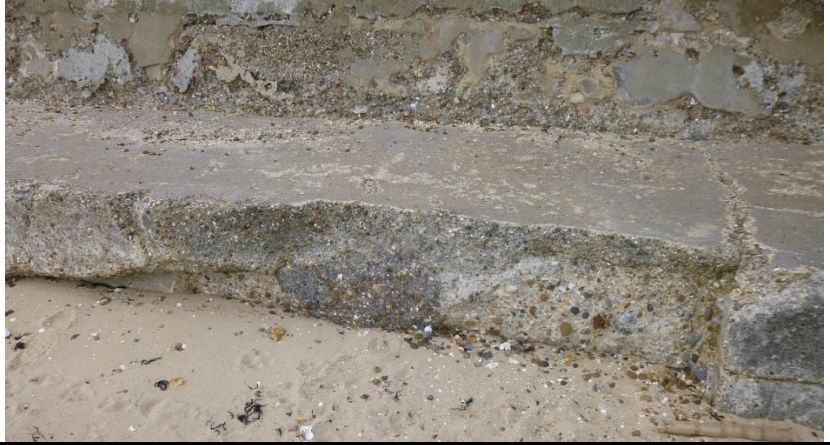
41		
1300-1350			<p>ESSENTIAL REPAIR: Repair of cracks in concrete is recommended</p>

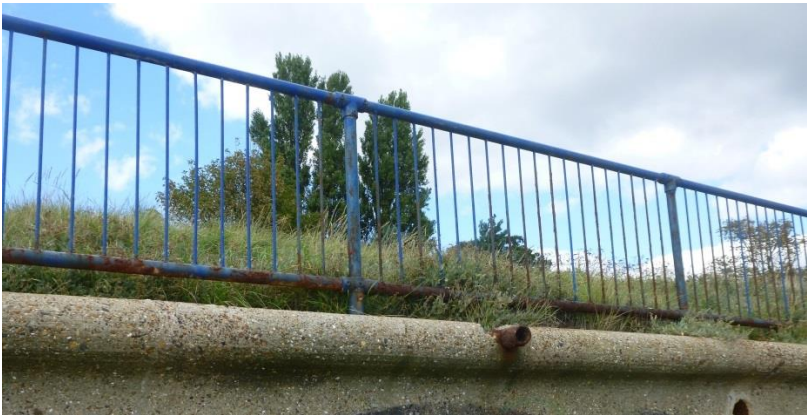
<p>RECOMMENDED REPAIR: Old fence is not structurally stable and replacement is recommended. Although not included in the contractual obligations repair is required on a health and safety basis.</p>

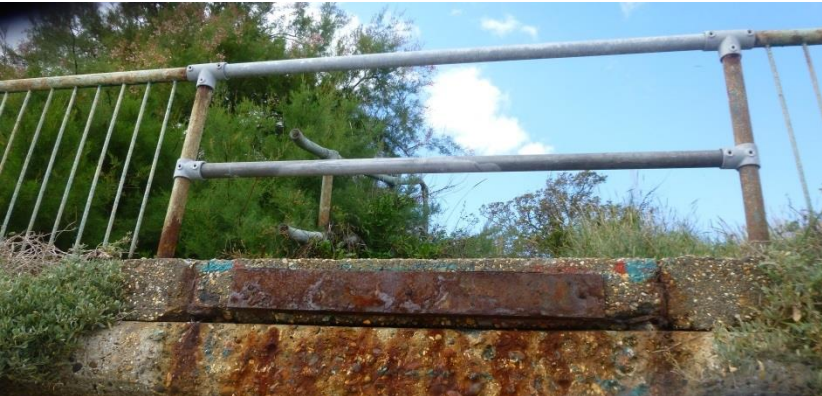
<p>Remove metal steps and close off access</p>	<p>Repair not satisfactorily completed. Metal steps have been removed and access closed off, but fixings have not been entirely removed. DESIRABLE REPAIR: Fixings should be removed and holes made adequately flush to the concrete with repair mortar</p>

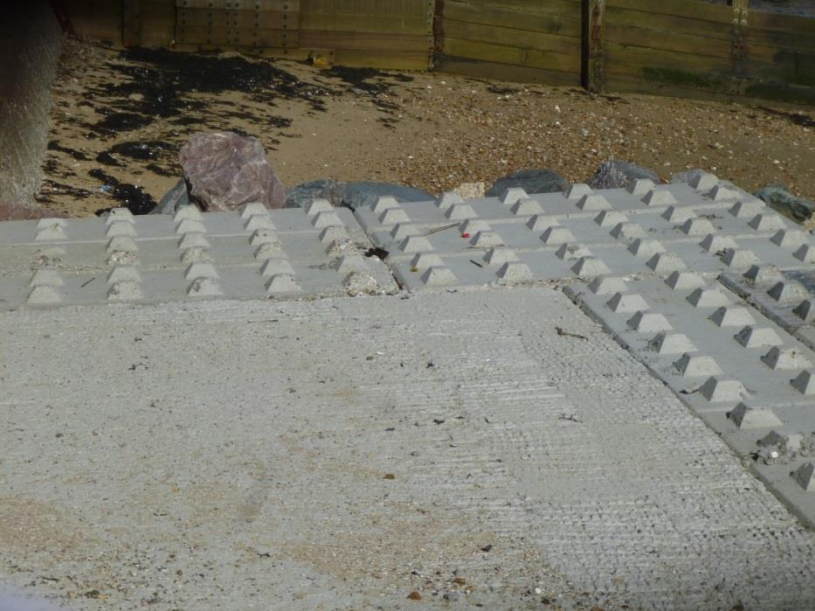
<p>Repair of embankment failure and Groynes 49-50 (completed by another contractor)</p>	<p>New concrete structure and rock revetment built to prevent further failure. Appears to be in good condition</p>

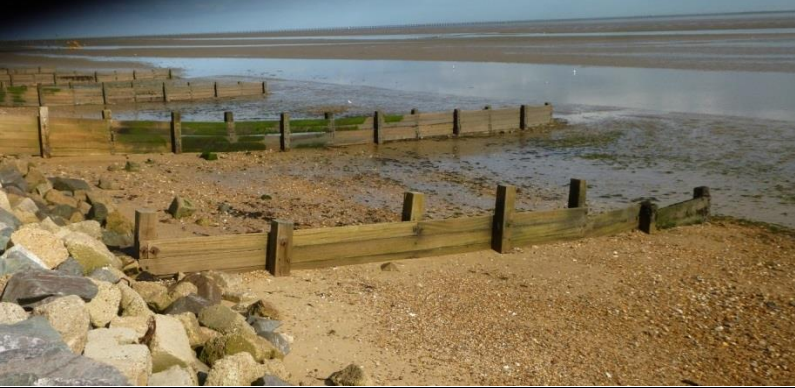
<p>ESSENTIAL REPAIR: Groynes require further repair</p>

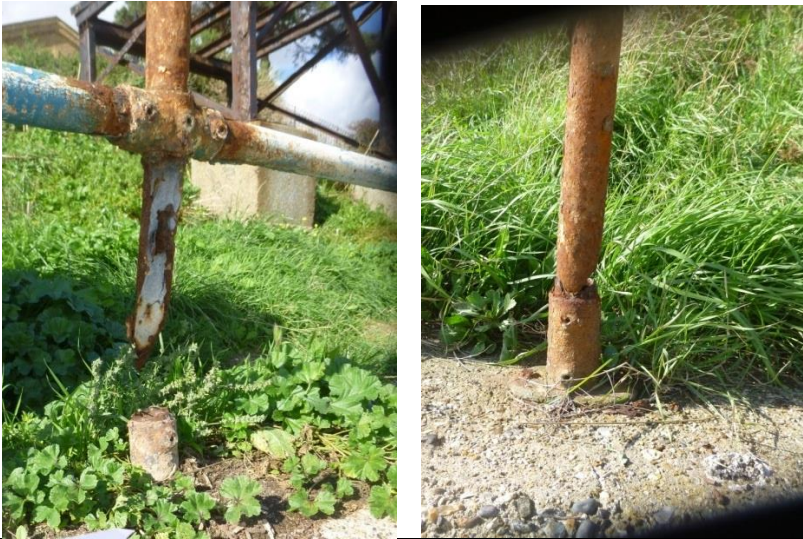
<p>RECOMMENDED REPAIR: Severely rusted and damaged handrail poses health and safety risk and requires replacing. Although not included in the contractual obligations repair is required on a health and safety basis.</p>

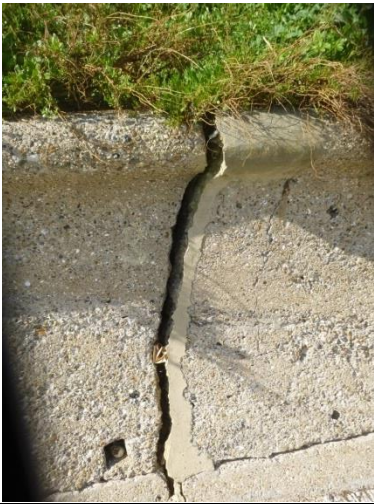
<p>1550-1600</p>	<p>51</p>		<p>ESSENTIAL REPAIR: Large crack (cm), sealant required</p>

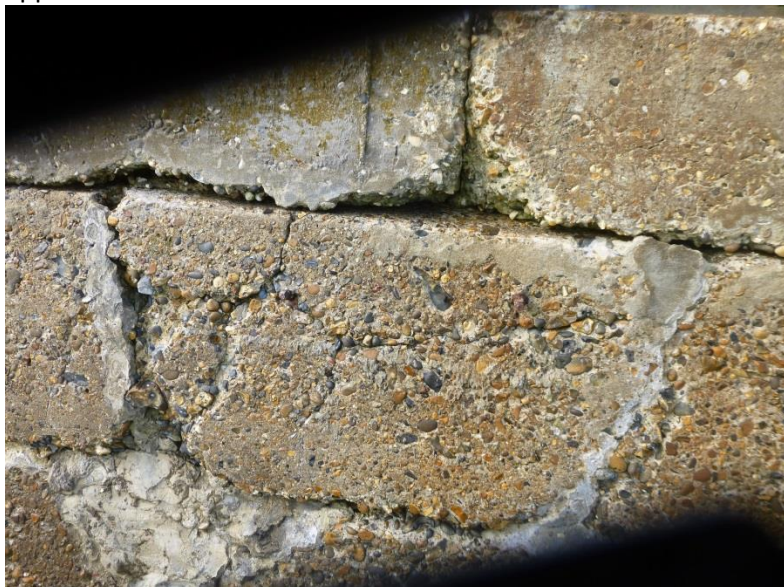
<p>ESSENTIAL REPAIR: Evidence of cracks (cm) in wall. Sealant should be applied to cracks</p>
