Assessment of coastal defence structures at Old Ranges, Shoeburyness

November 2015

Southend-on-Sea Borough Council

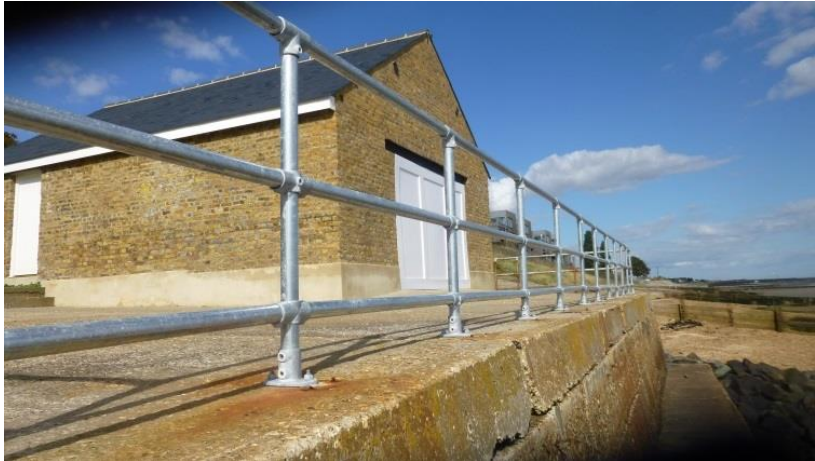
<p>Boathouse</p> <p>Remove metal staircase, metal handrail and close off access</p>	<p>Partially completed works. Access closed off to Boathouse, metal staircase removed and rock moved to protect wall. New guardrail added.</p>

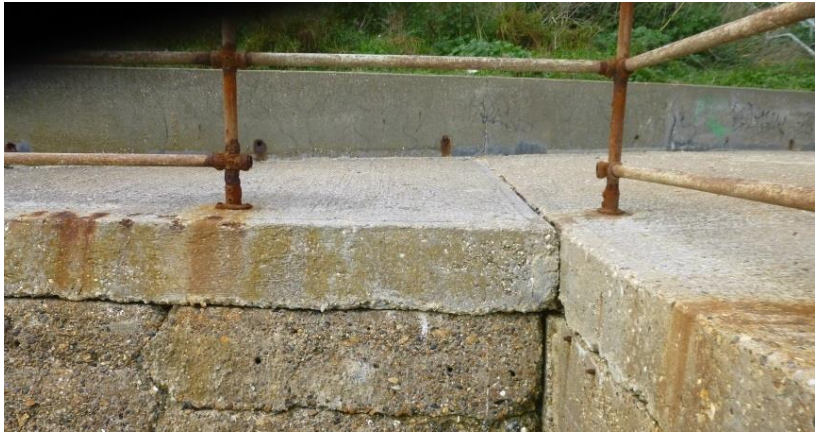
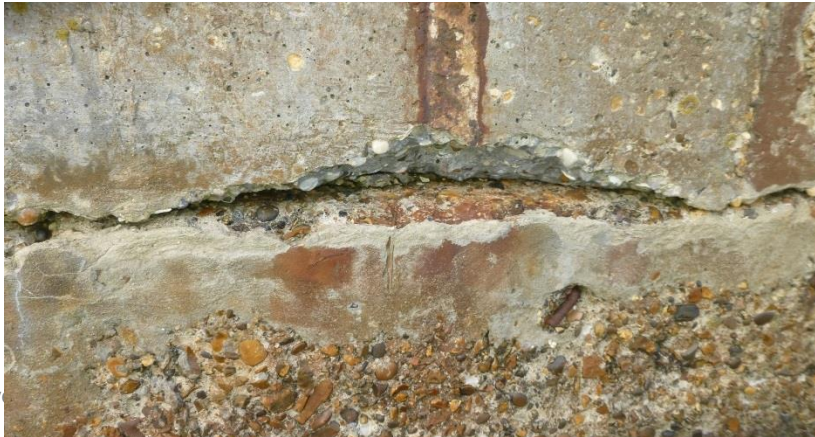
<p>ESSENTIAL REPAIR: However section of handrail requires replacement DESIRABLE REPAIR: Many bolts are still to be removed and holes made flush with concrete face using repair mortar. Cracks to wall face noted.</p>

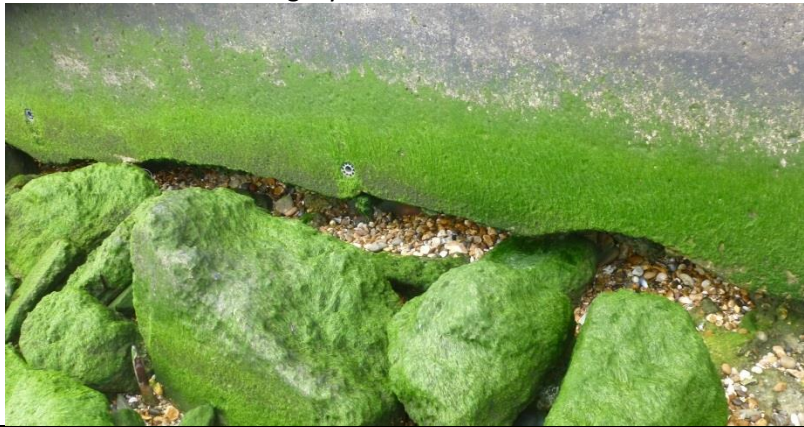
53		
1650-1700			<p>RECOMMENDED REPAIR: Although not included in the contractual obligations the undermining of the concrete slab requires repair to maintain structural integrity.</p>

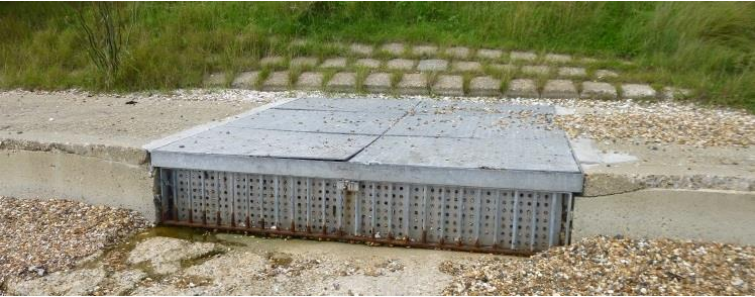
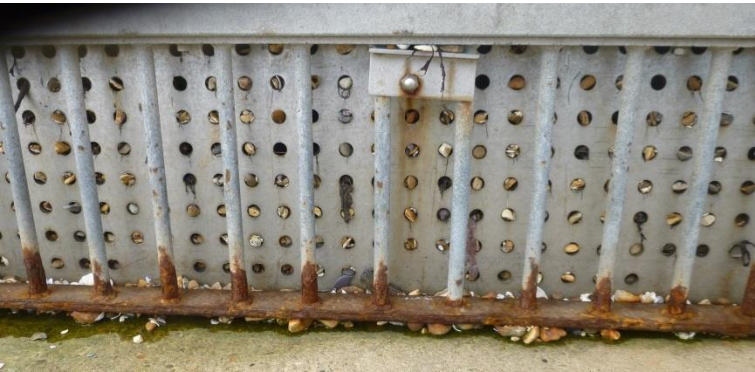
<p>Drainage outfall</p>	<p>Beyond scope but noted for completeness. Partly blocked by deposited shingle. Would benefit from cleaning out to allow greater flow rates.</p>

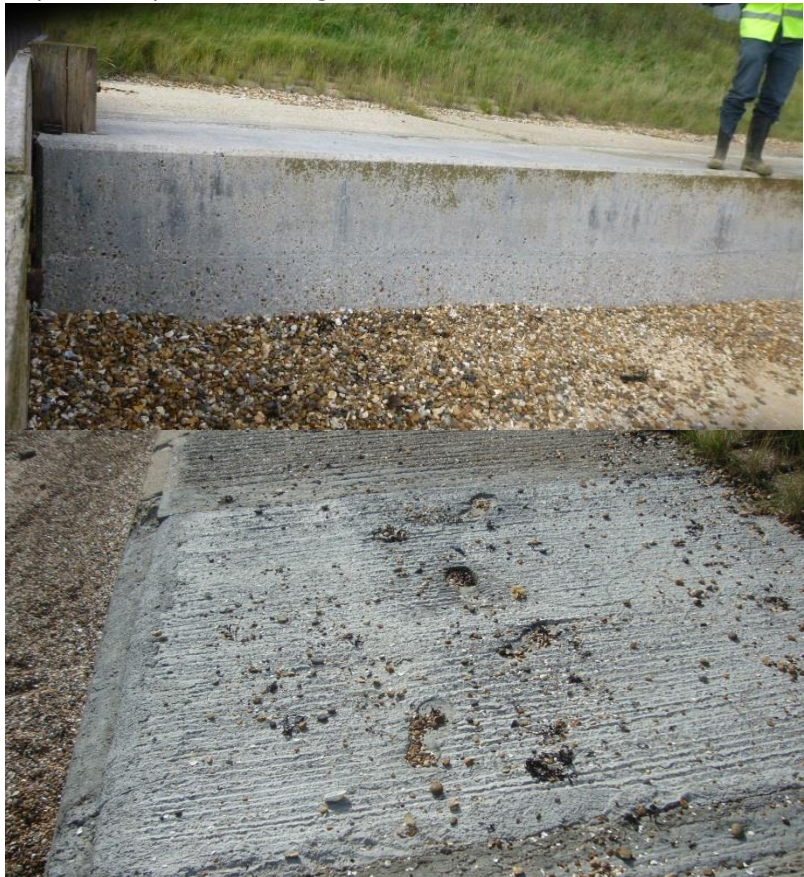
1750-1800		Repair to concrete slab at Groyne 56	Repairs completed and in good condition
	56

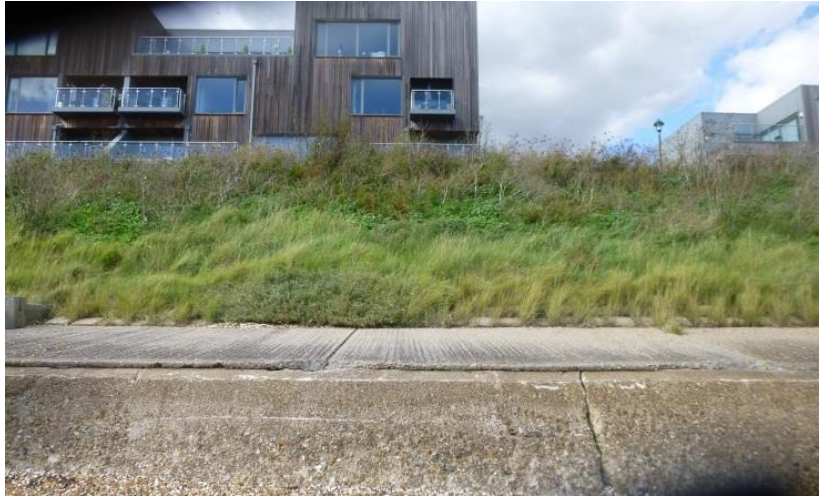
57		<p>DESIRABLE REPAIR: Vegetation on revetment to be removed and joints made good with sealant as necessary</p>
