Flood Investigation Report

Victoria Road Area, Southend-on-Sea
Flood of 20th October 2021

March 2023

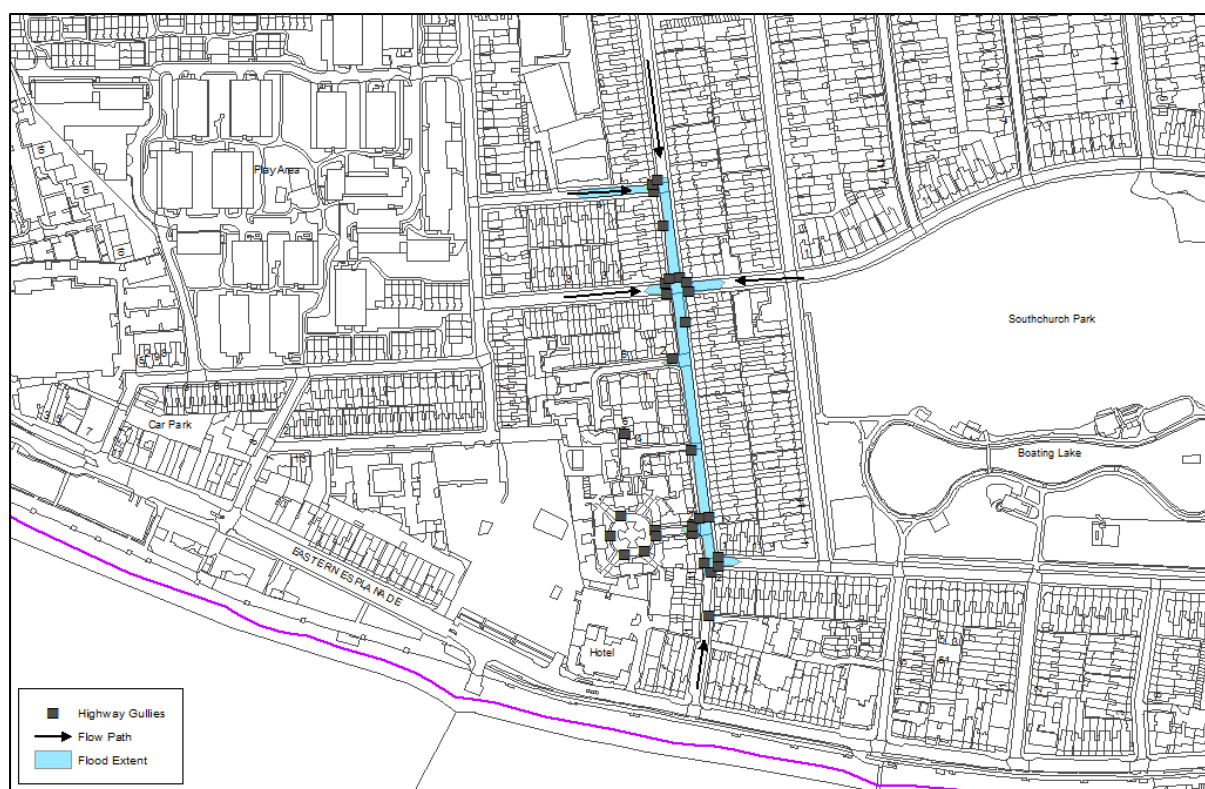
Figure 6.1: Map showing the flood extent and recorded flood flow routes

Anecdotal information suggests that shortly following the intense rainfall peaks around 10-11pm some surface water started flowing from the surrounding higher land towards Victoria Road using the road surfaces as a drainage flow path. Shortly after surface water mixed with foul effluent started surcharging from the Manilla Road area, flowing east to Victoria Road and then south impacting the areas along Victoria Road and affecting areas around the Northumberland Crescent, Collier Way, Jetty Mews and Shaftesbury Avenue junctions. These flows gathered at the localised low point on Victoria Road between Collier Way and Shaftesbury Avenue. Figure 6.1 outlines the maximum flood extent and surface flow routes.

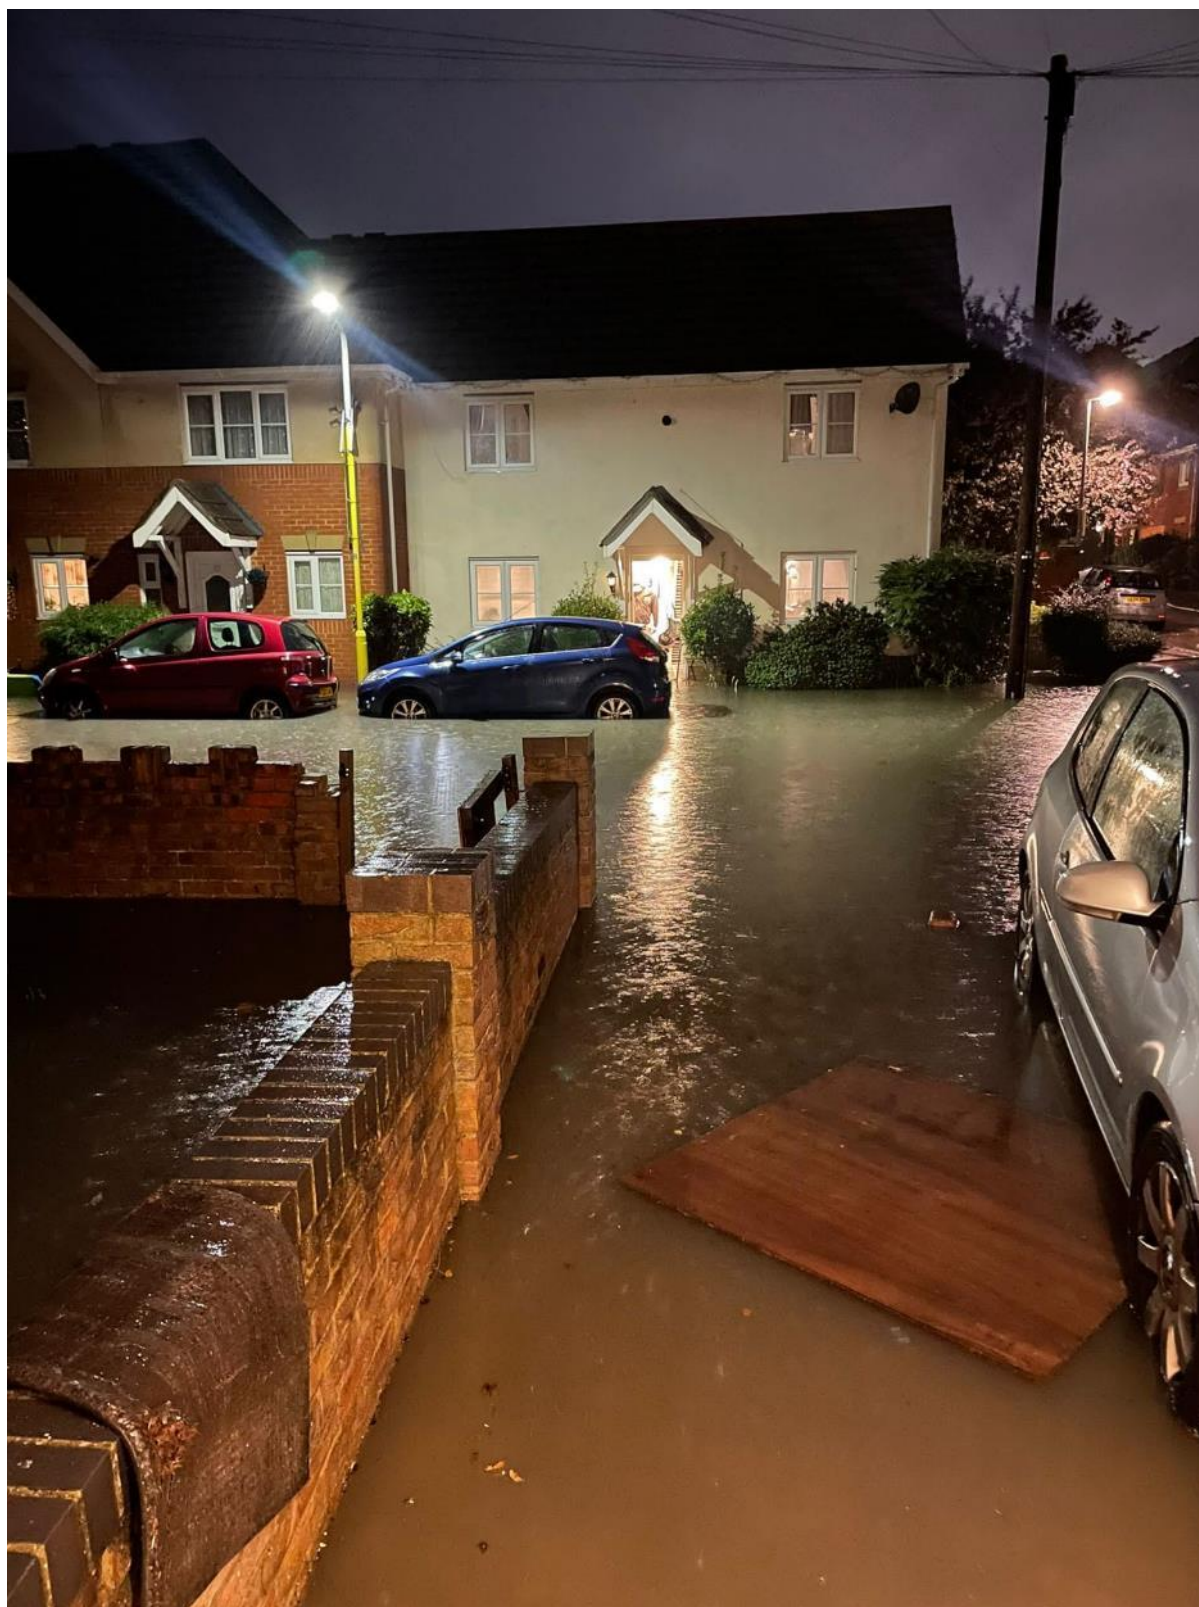
Photo 1: Extent of flooding, looking towards Victoria Road and Collier Way junction (1)

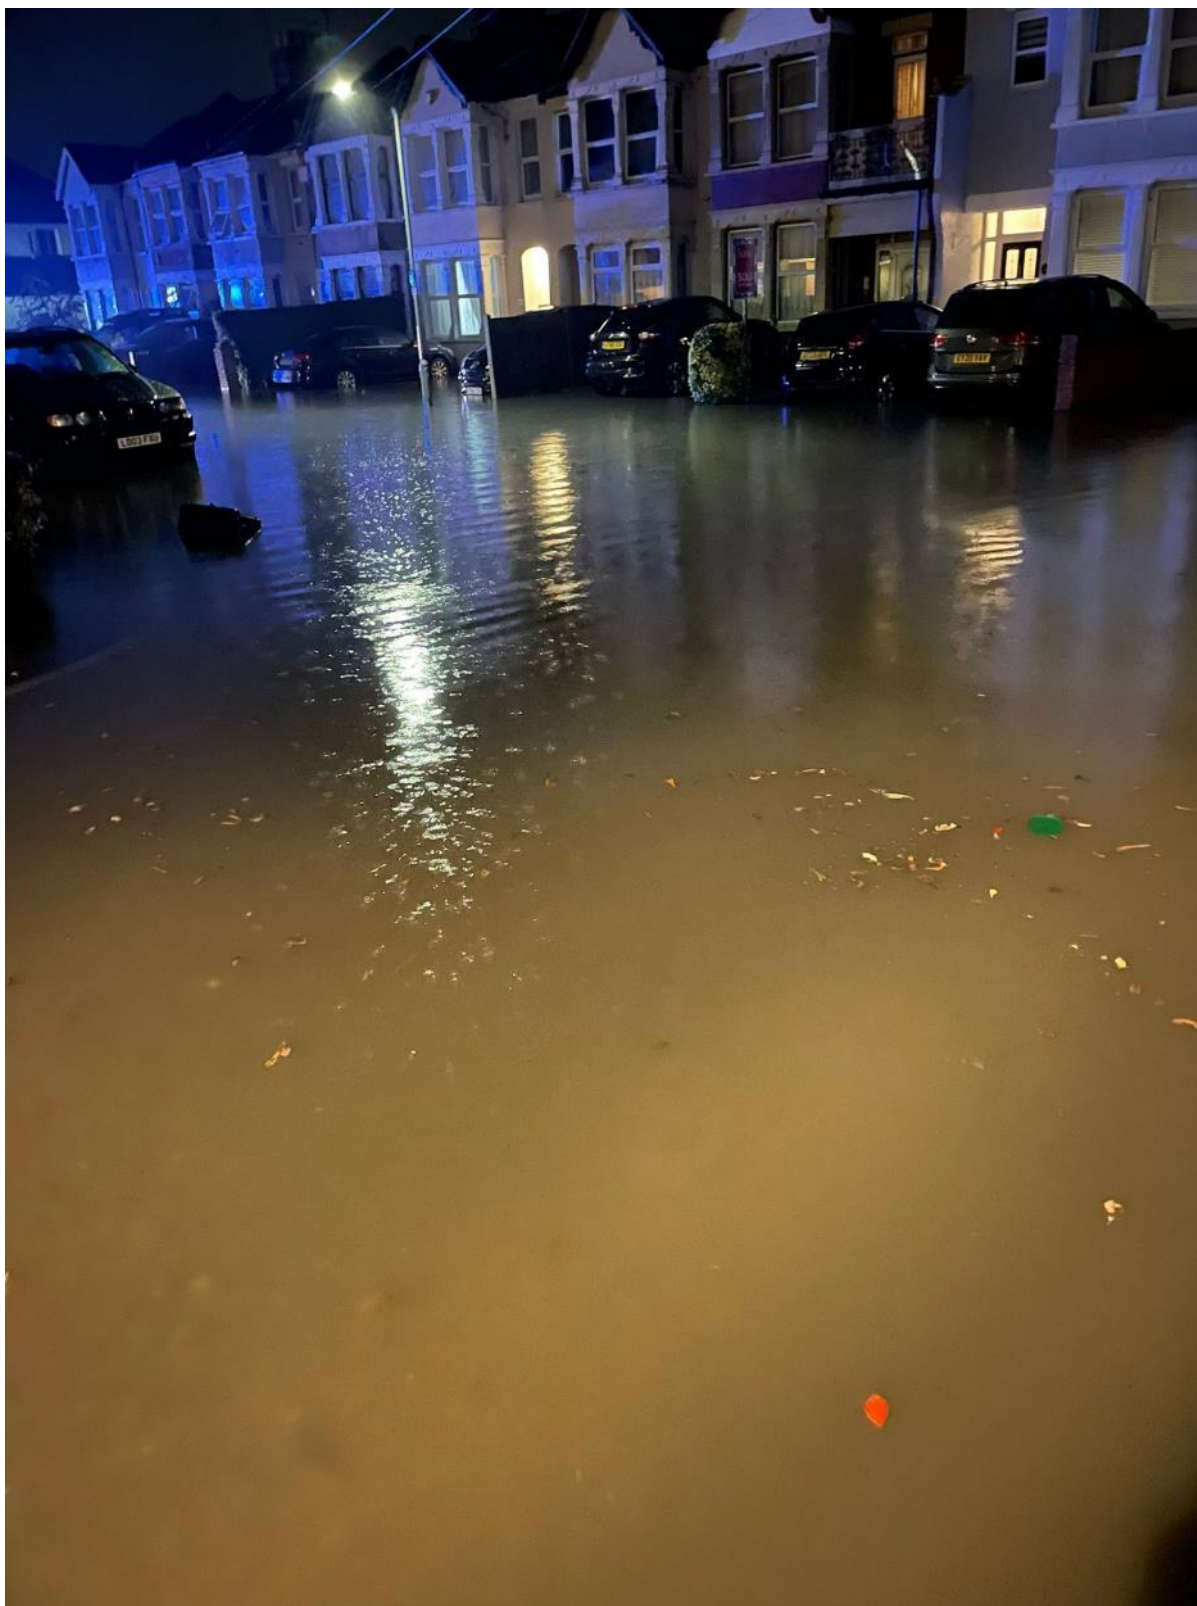
Photo 2: Extent of flooding, looking towards Victoria Road and Collier Way junction (2)

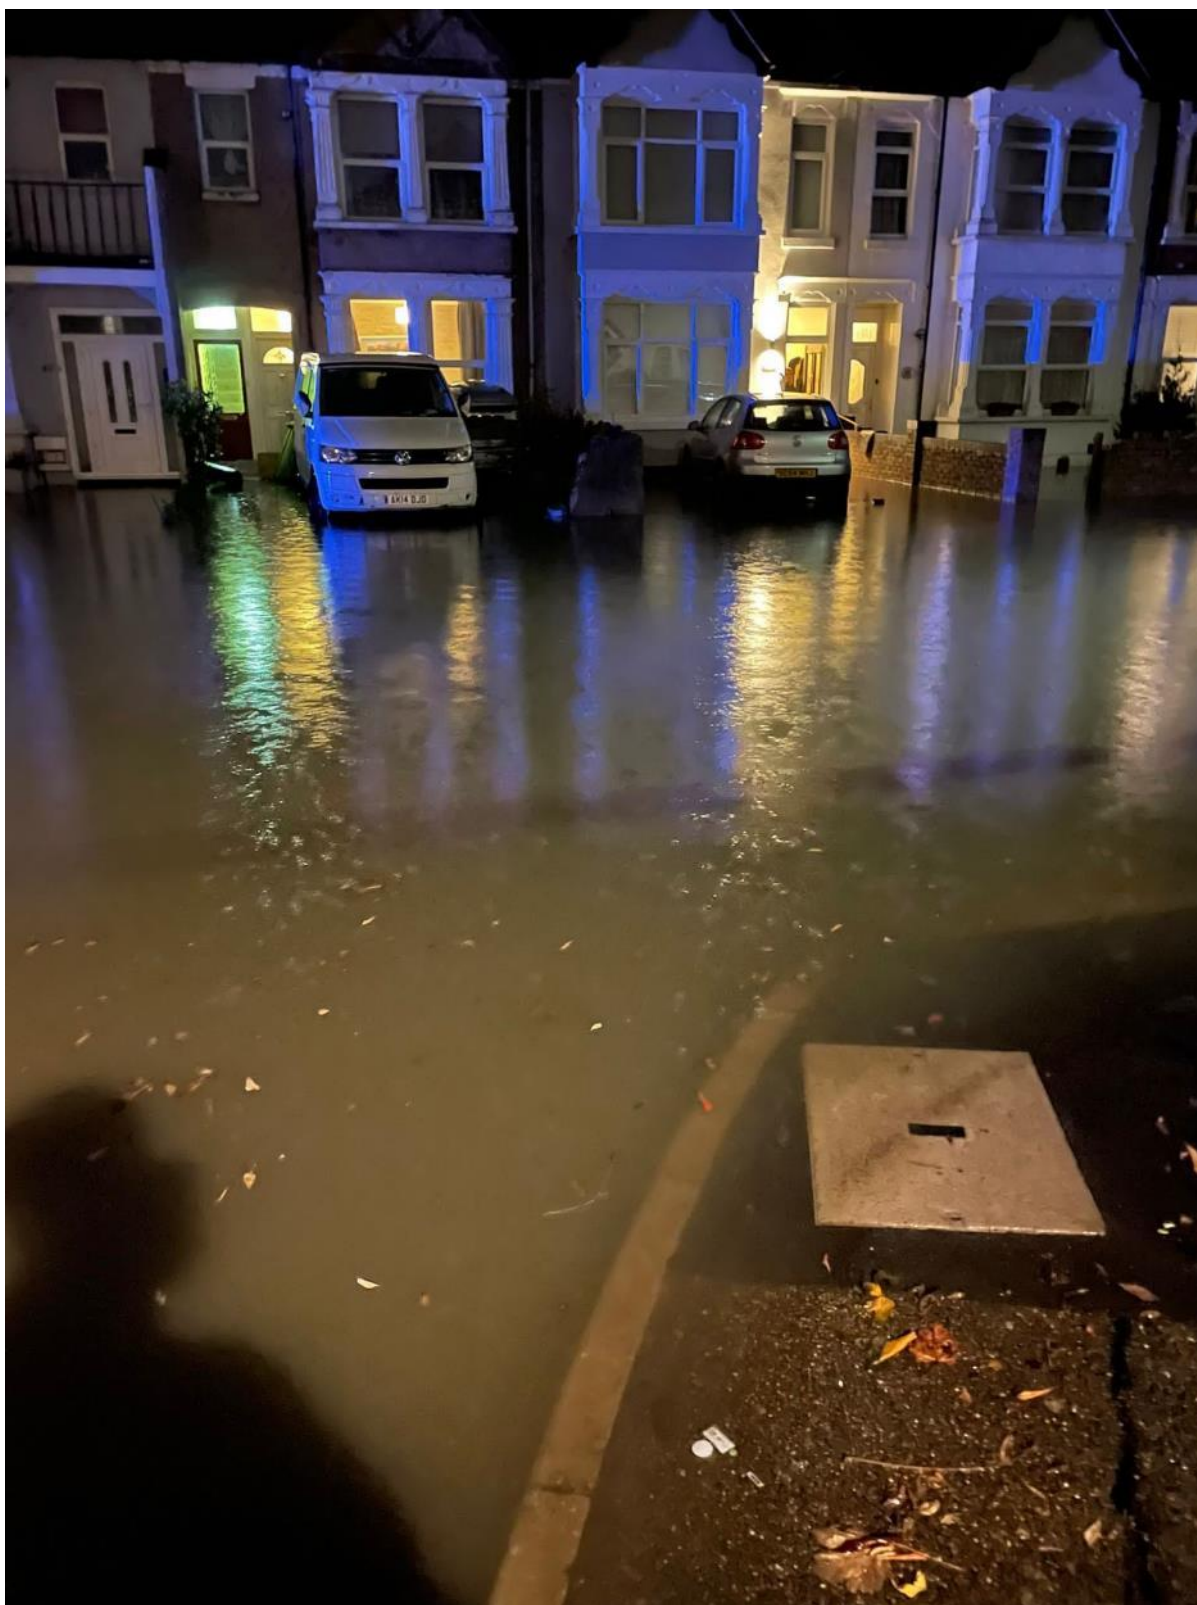
Photo 3: Extent of flooding at the Victoria Road and Collier Way junction

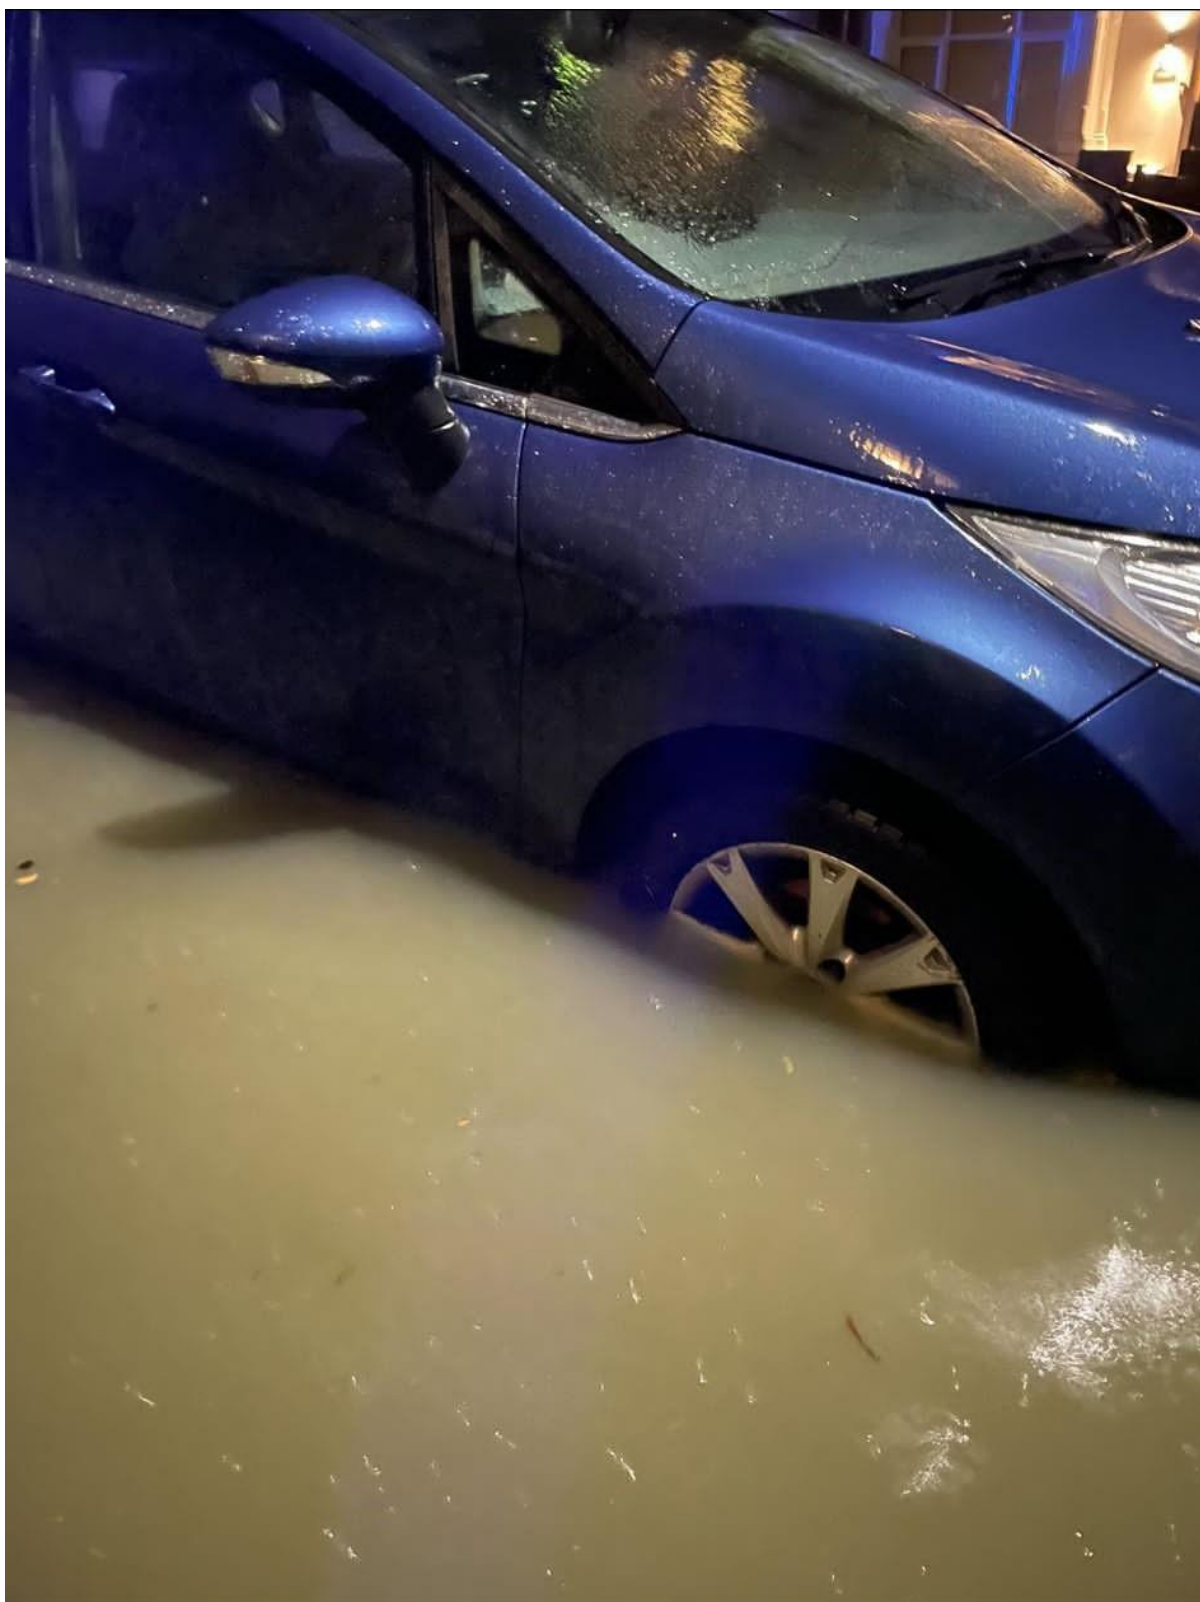
Photo 4: Flood depths on Victoria Road

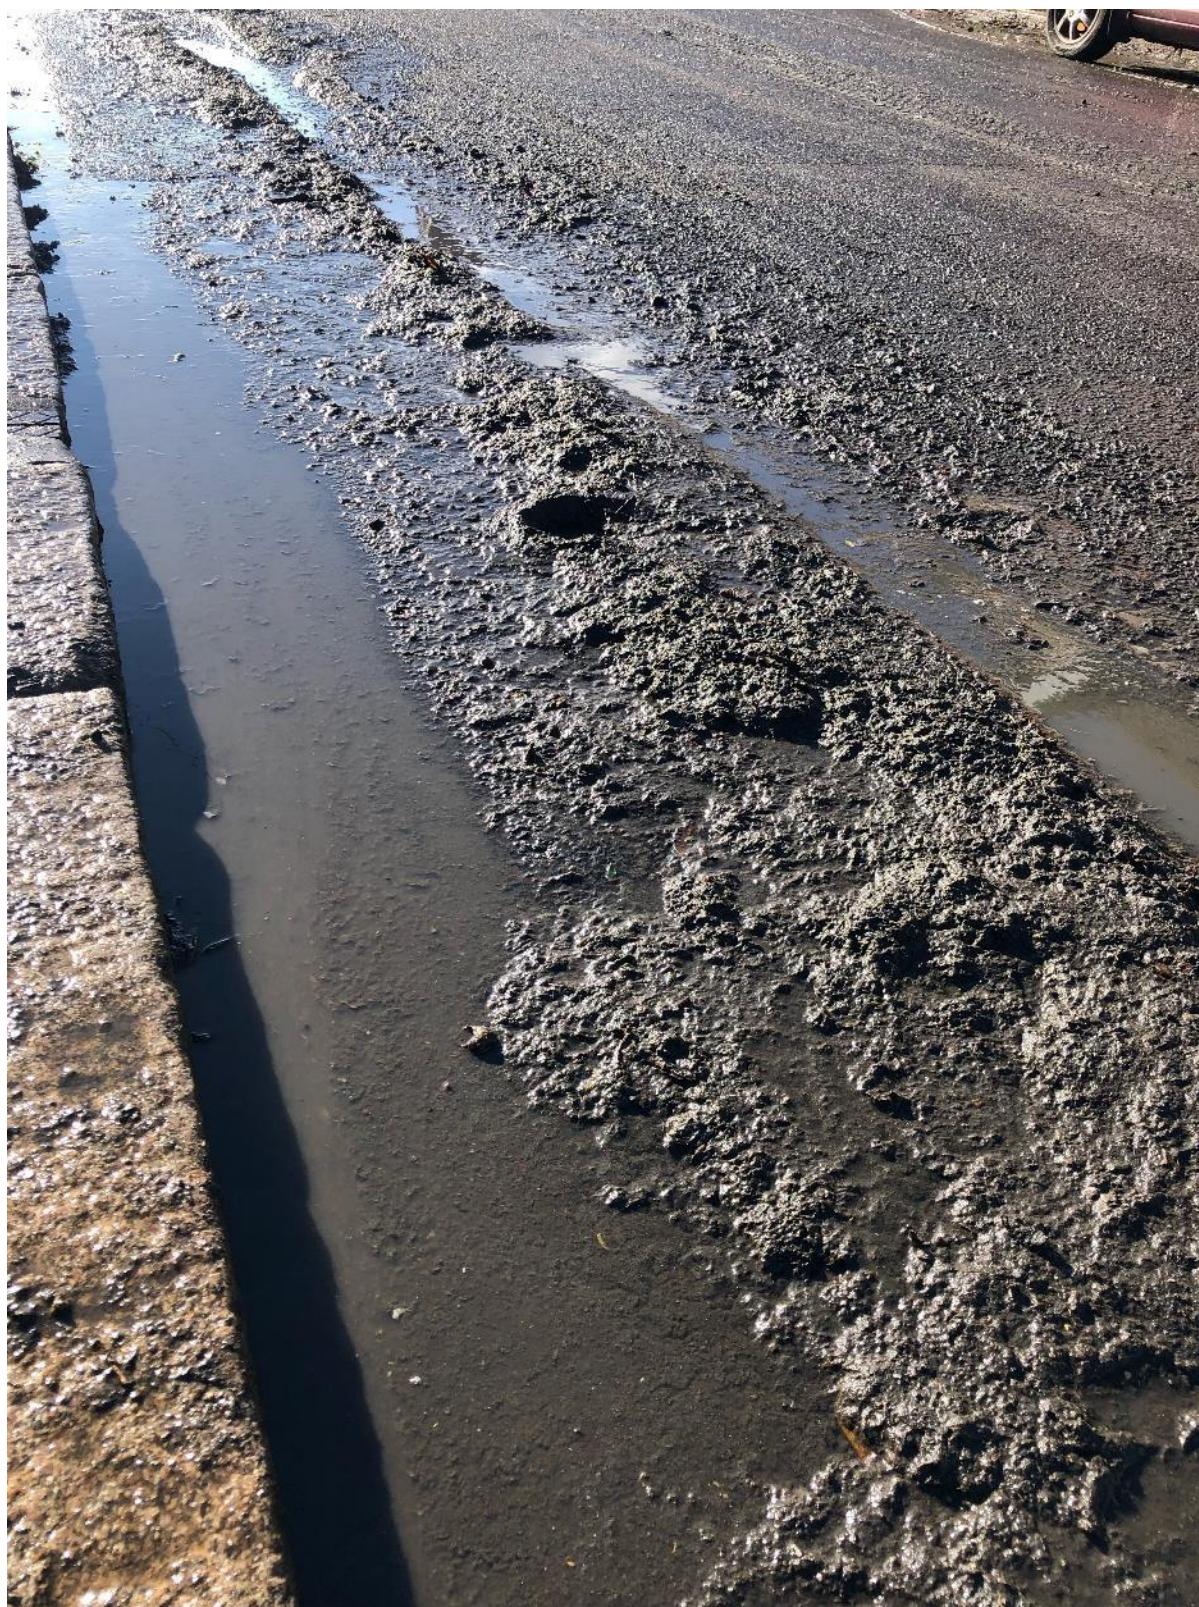
Photo 5: Post flooding debris (1)

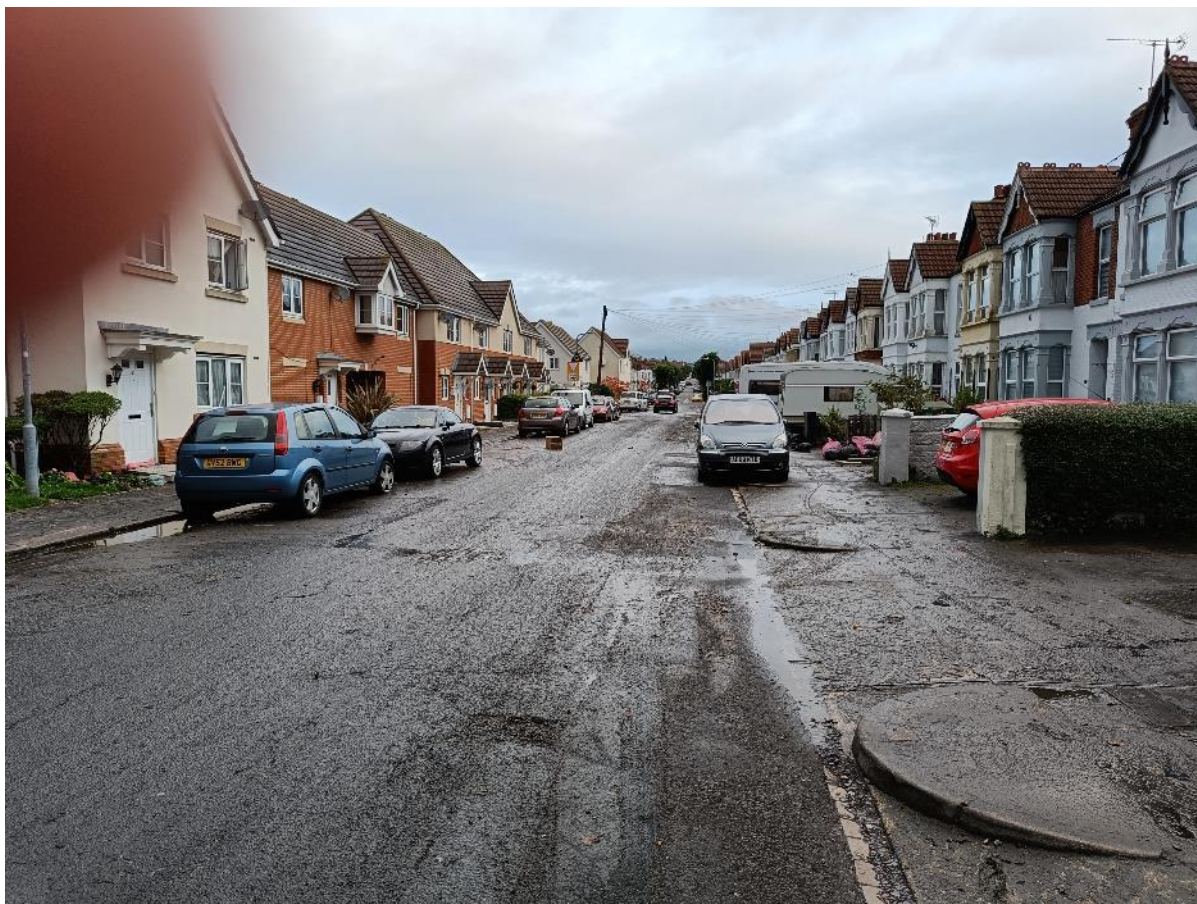
Photo 6: Post flooding debris (2)
