Flood Investigation Report

**Rayleigh Road and Glenwood Avenue,
Leigh-on-Sea**

**Floods of 20th October 2021
and 20th February 2022**

March 2023

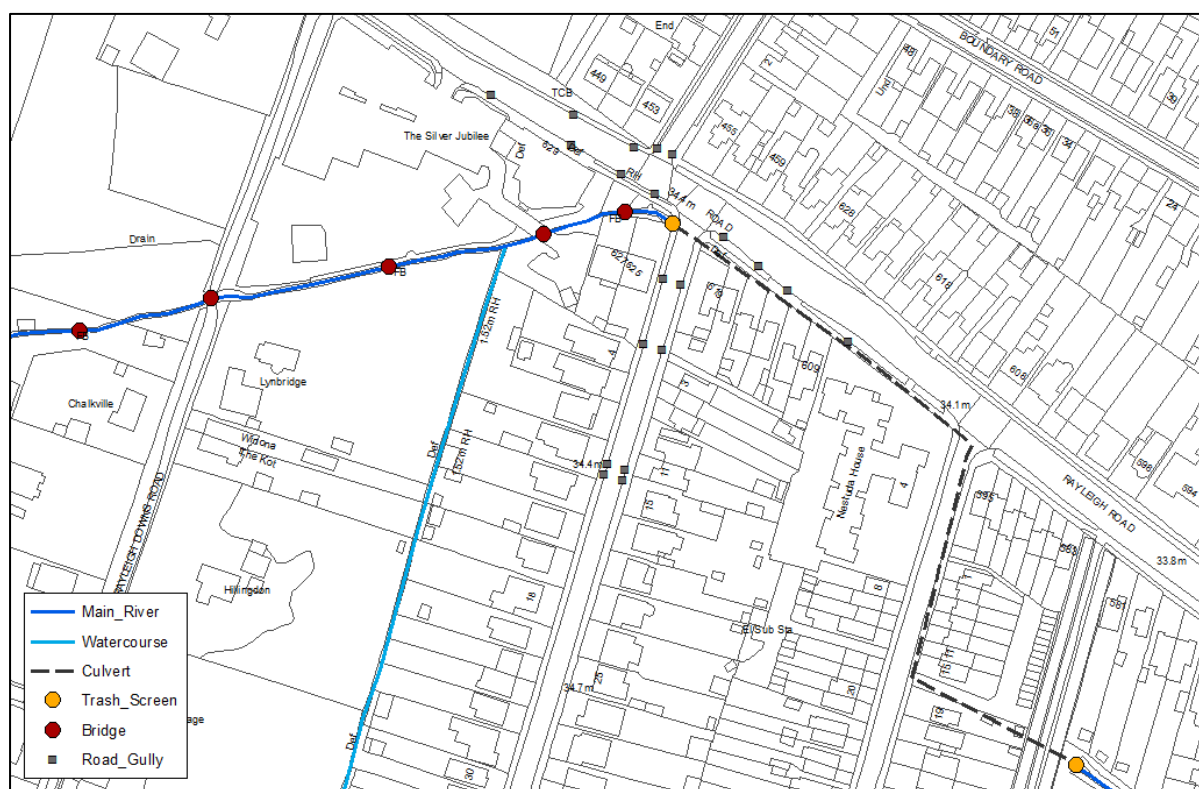
Figure 3.2: Observed and recorded drainage in the investigation area

Highway drainage exists within Glenwood Avenue, Rayleigh Road and surrounding residential roads. Drains exist at 20-50m intervals on all residential roads, with one each side of the road, in line with design standards. All were observed to be clear during an inspection undertaken on 4th November 2021.

A main river, the Eastwood Brook runs through the middle of the area from West to east and passes through a 1500mm diameter culvert between Glenwood Avenue and Grovewood Avenue. This was observed to be free flowing and clear of any silt and debris obstructions during the inspection.

A sloped trash screen exists at the upstream end of the culvert where it joins the open section of channel to collect debris and reduce the risk of blockages. This was observed to be clear during the site inspection.

Figure 3.2 shows the recorded drainage in the vicinity of the site. It should be noted that no foul systems or highway drainage lateral pipes are shown. Only road gullies relevant to the problems location are detailed.

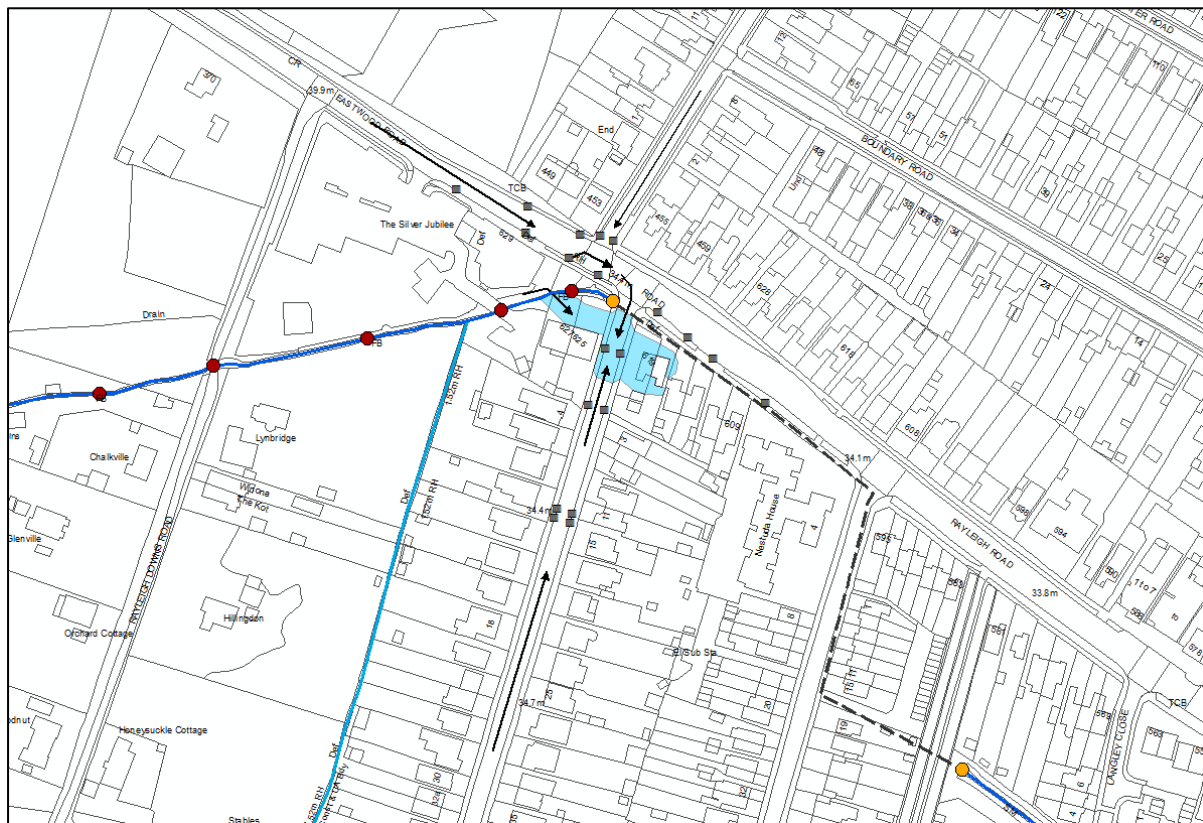
Figure 6.1: Map showing the flood extent and recorded flood flow routes

Based on the above data and evidence received from local residents the flooding is most likely to have occurred due to the result of high rainfall volumes compounded by localised, intense rainfall and some debris blockages within the Eastwood Brook.

A map showing the flood routes and extents is shown in Figure 6.1.

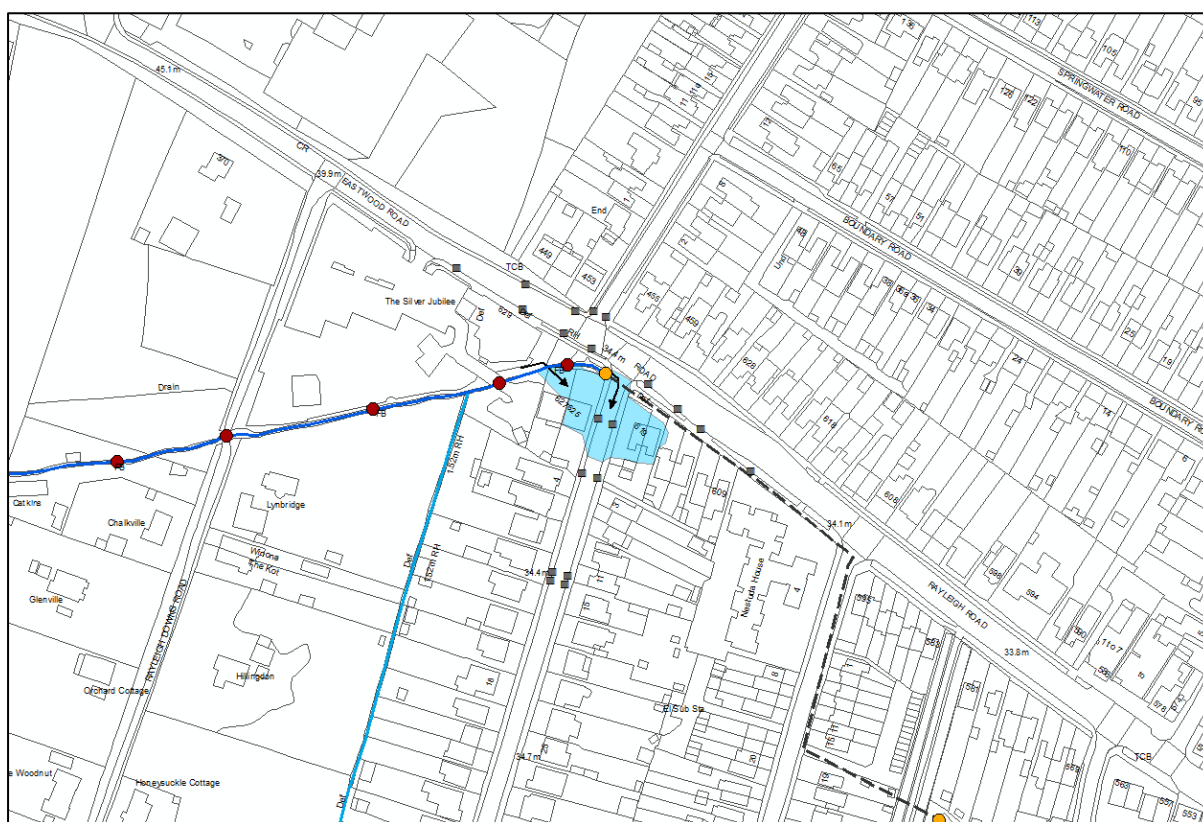
Figure 7.1: Map showing the flood extent and recorded flood flow routes

Based on the above data and evidence received from local residents the flooding is most likely to have occurred due to the result of localised, intense rainfall and a significant blockage within the Eastwood Brook caused the flooding.

A map showing the flood routes and extents is shown in Figure 7.1.

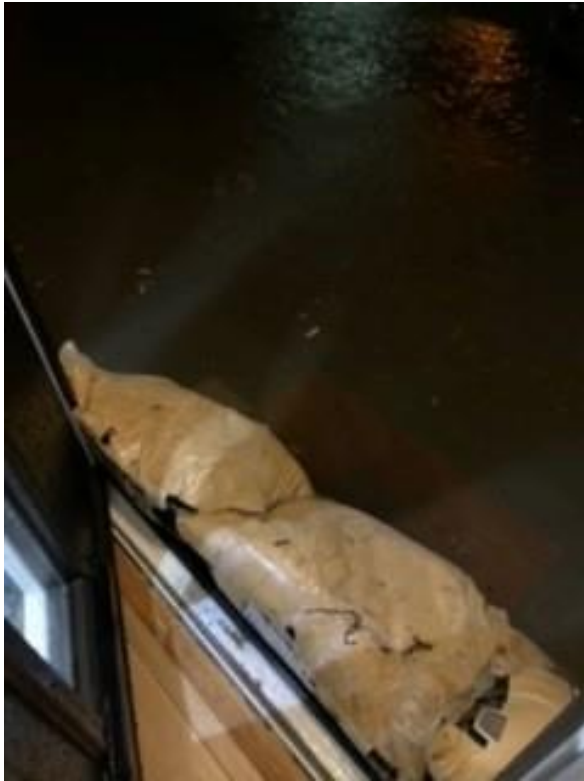
Photo 1 – No. 619

Following heavy rain on the evening of 20 October 2021 flooding commenced to 619 Rayleigh Road at approximately 22:00 with water entering the house at around 23:00. Water levels reached approximately 400mm in the garage and approximately 100mm in the house and persisted for 2-3 hours, receding by 02:00 on the 21st October.

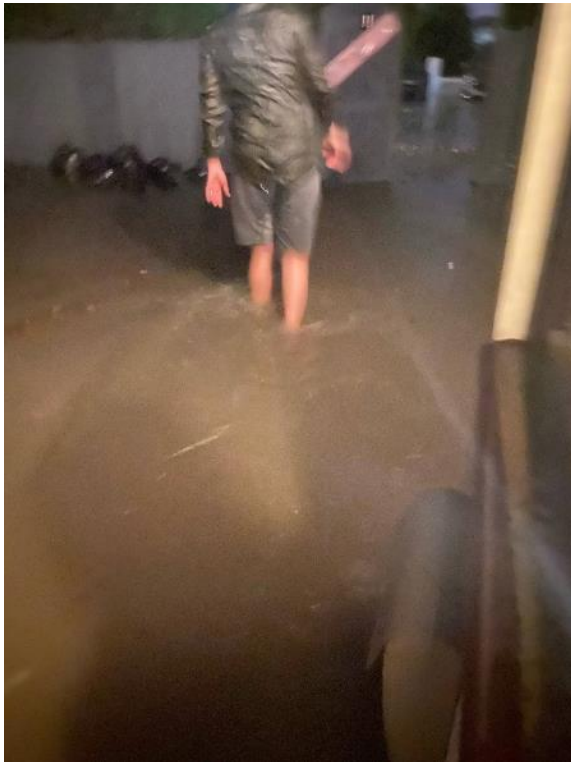
Photo 3 – No. 625 Garden

The property at 625 had extensive flooding of approximately 250mm depth in the garden with no internal flooding occurring to the property. No other flooding was recorded or reported regarding other properties in the immediate area.

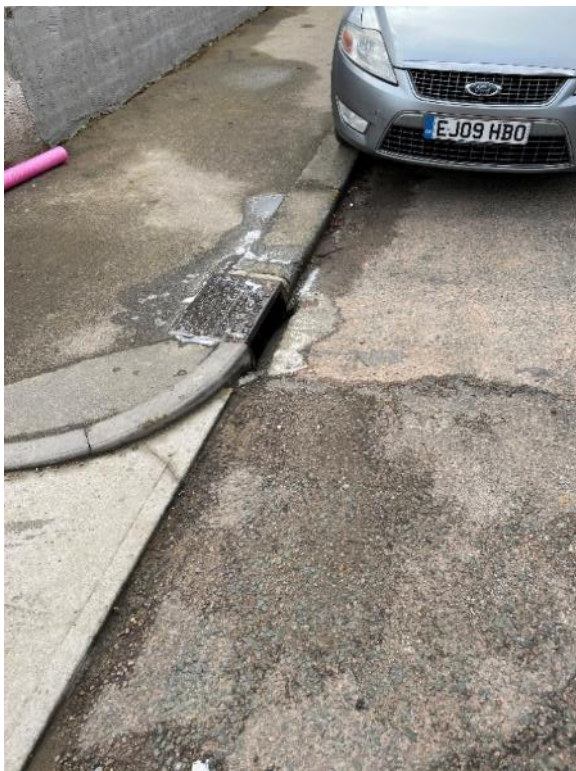
Highway drains (pipework blockages)	It was reported that water was surcharging from a gully on Rayleigh Road, indicating a potential blockage in the drainage system. This will both prevent surface water entering, contributing to the flooding and also add additional water to the flood area that otherwise would have drained away through pipework	Low	Medium
Highway drains (gully blockages)	During the autumn months highway drainage is more prone to blockages from falling leaves, twigs and other debris. Reports suggest that this was not a significant factor in causing the flood event and no evidence was found of debris blockages during the site inspection however the potential for debris to have created localised blockages or restrictions during the flood event is possible	Low	Low
Highway drains (number)	The lack of gullies in the immediate vicinity of the flooding resulted in water not being able to drain away quickly enough. It should be noted that the rainfall volume exceeded the 3.3% AEP design drainage rates and that water drained away quickly once the rainfall subsided, indicating the pipework to be clear and the flooding due to the volume of rainfall	High	Medium

Photo 5 – Road gully outside no. 619

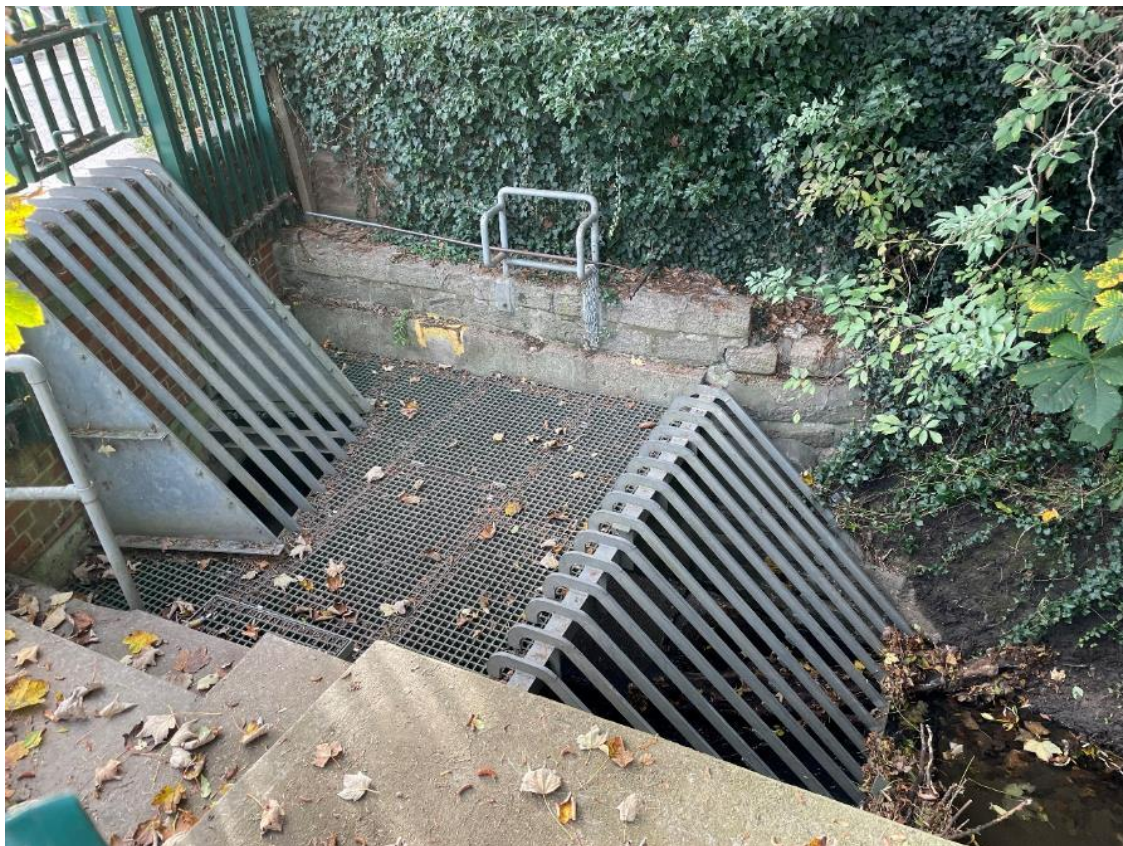
Aspect	Details	Likelihood	Impact
	combined with potential debris and obstructions causing the channel to overtop		
Obstructions to Eastwood Brook and trash screen	Evidence suggests that there may have been debris obstructions to the trash screen and/or bridges within Eastwood Brook upstream of the study area that contributed to the channel overtopping. It should be noted that the AW trash screen was cleared quickly during the event. Due to lack of evidence the specific role of this factor in the flood event cannot be fully quantified	High	Medium
Trash screen	It was observed that the trash screen constitutes a single sloped grille with a bar spacing of roughly 100mm. The design could be changed to further minimise the risk of blockages and reduce the requirement for maintenance during heavy rainfall events	Medium	Medium
Eastwood Brook	Whilst clear at the time of inspection the above issues with blockages indicate material entering the channel further up may be an issue	High	Medium

Photo 7 – Eastwood Brook trash screen at corner of Glenwood Avenue

Authority	Date	Details	Actions
AW	20/10/2021	Trash screen check during event	Screen checked and cleared to remove any debris. As of Winter 2022 monitoring equipment is being installed upstream of the screen to allow clearance works to be more efficient
SCC	04/11/2021	Site visit to gather information from affected residents and inspect drainage	No issues identified with drainage, maintenance regime to be checked. Section 19 Report commenced
SCC	November 2021	Eastwood Brook Flood Scheme	Details surrounding the flood event fed into wider project investigating the viability of delivering flood alleviation measures in the Eastwood Brook catchment. As of Winter 2022 modelling and economic analysis of possible options benefitting the study area has been completed. Optioneering and detailed design will be commencing in 2023/2024
SCC	December 2021	Consideration for drainage improvement works	Budget secured to deliver drainage improvement works across Southend, location added to list for consideration of receipt of a supergully to help improve highway drainage immediately adjacent to affected properties. As of Winter 2022 designs have been finalised and works are currently being programmed

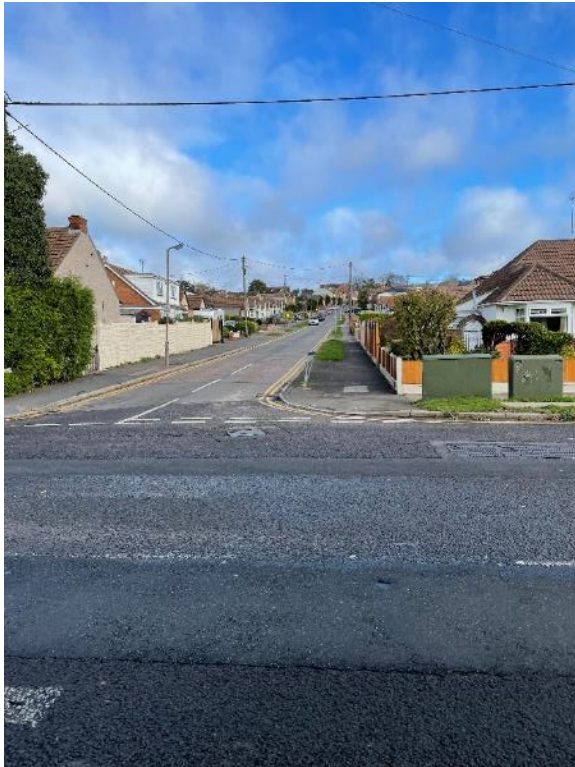
Photo 8 – Rayleigh Avenue – flow reported down here towards Glenwood Avenue **Photo 9 – Rayleigh Road**
