Assessment of coastal defence structures at Old Ranges, Shoeburyness

November 2015

Southend-on-Sea Borough Council

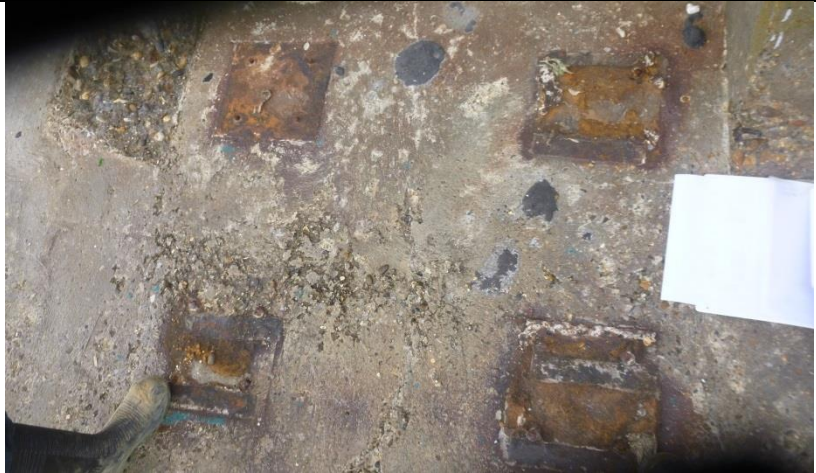
43

<p>Remove metal steps and close off access</p>	<p>Repair not satisfactorily completed. Metal steps have been removed and access closed off, but fixings have not been entirely removed. DESIRABLE REPAIR: Fixings should be removed and holes made adequately flush to the concrete with repair mortar</p>
