Flood Investigation Report

**Rayleigh Road and Glenwood Avenue,
Leigh-on-Sea**

**Floods of 20th October 2021
and 20th February 2022**

March 2023

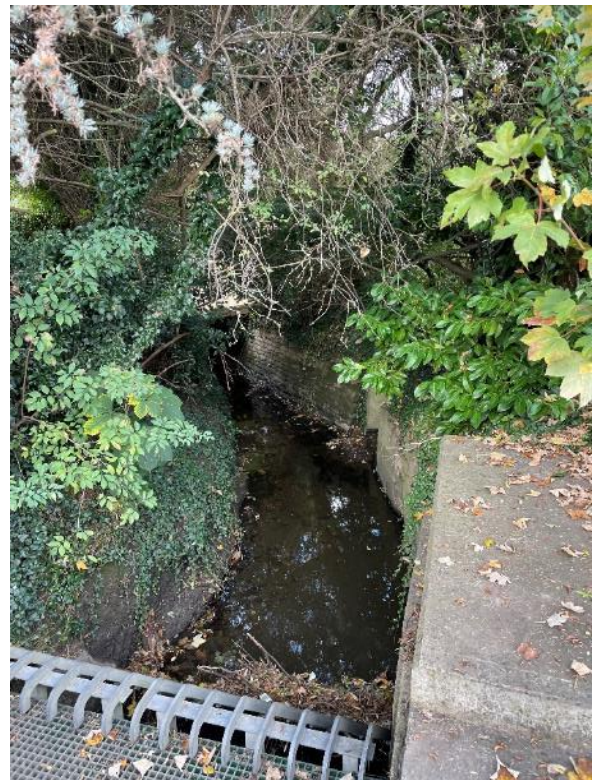
A main river, the Eastwood Brook runs through the middle of the area from West to east and passes through a 1500mm diameter culvert between Glenwood Avenue and Grovewood Avenue. This was observed to be free flowing and clear of any silt and debris obstructions during the inspection.

Photo 6 – Eastwood Brook at corner of Glenwood Avenue

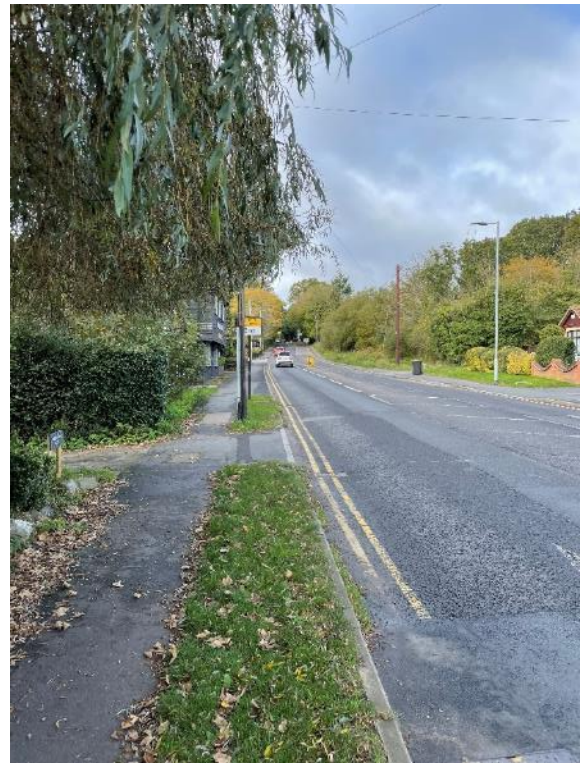
Photo 8 – Rayleigh Avenue – flow reported down here towards Glenwood Avenue **Photo 9 – Rayleigh Road**
